Capsizing and Sinking of
Commercial Fishing Vessel *Scandies Rose*
Sutwik Island, Alaska
December 31, 2019

Marine Accident Report

NTSB/MAR-21/02
PB2021-100924

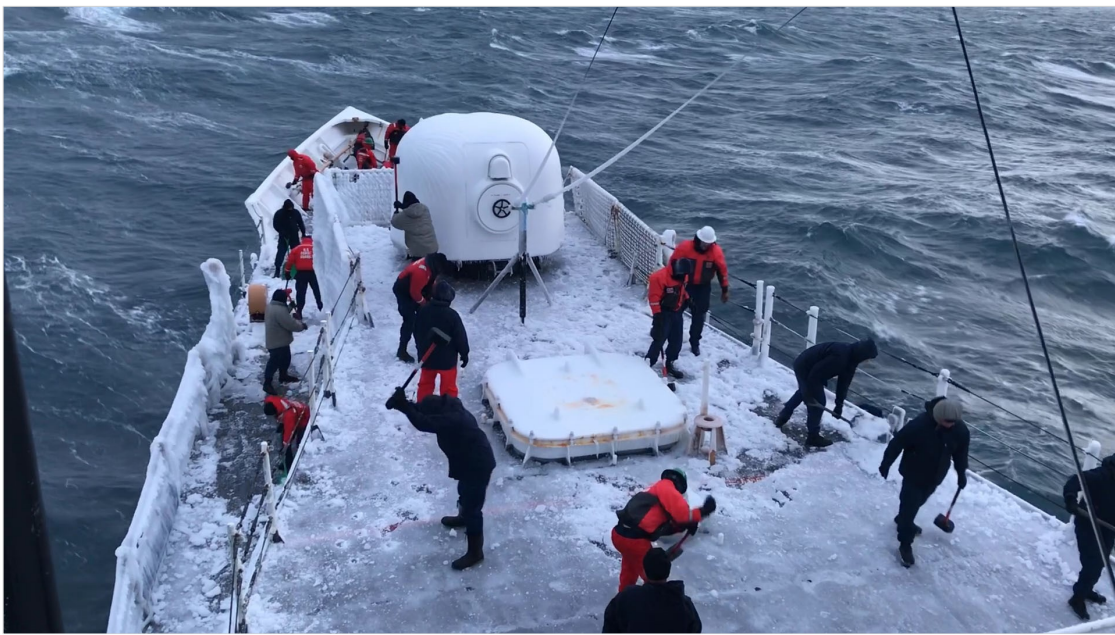
The captain of the *Mellon* reported that they arrived on scene around 1615 on January 1, but they had to stop the search pattern to break ice before sunset (1701) because 2 to 3 inches of solid ice had accumulated on the deck during the voyage, as shown in figure 8. The icing had built on the ship asymmetrically, and they had to steer 40° off their intended course due to the wind and waves to maintain search lines.

Figure 8. USCGC *Mellon* crew breaking ice during search efforts late afternoon on January 1.

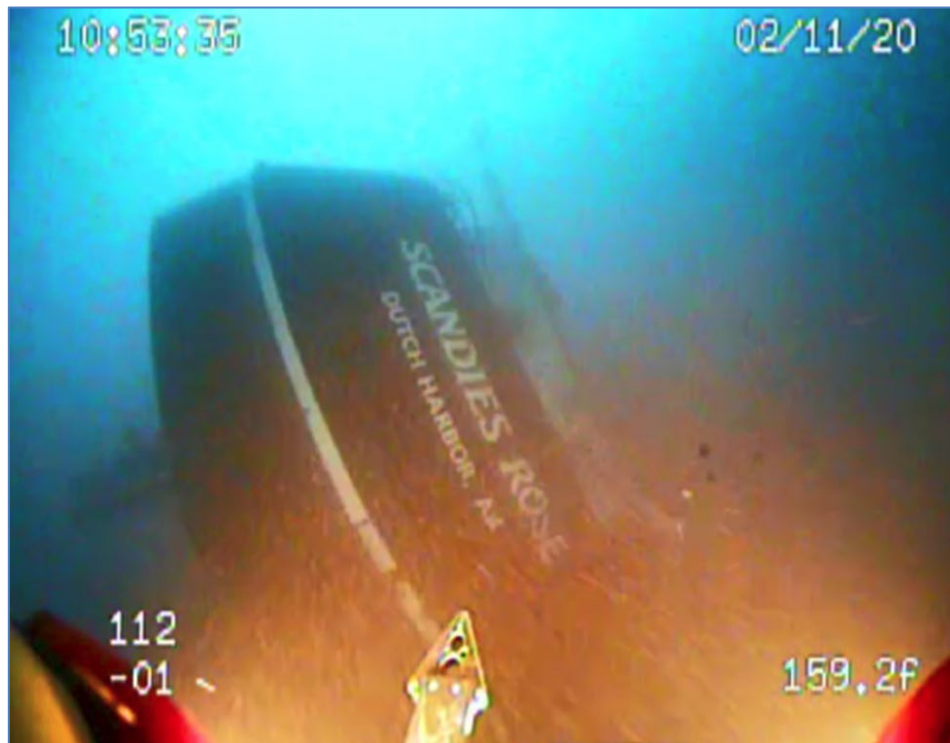
Figure 9. The *Scandies Rose* wreck, located on February 11.

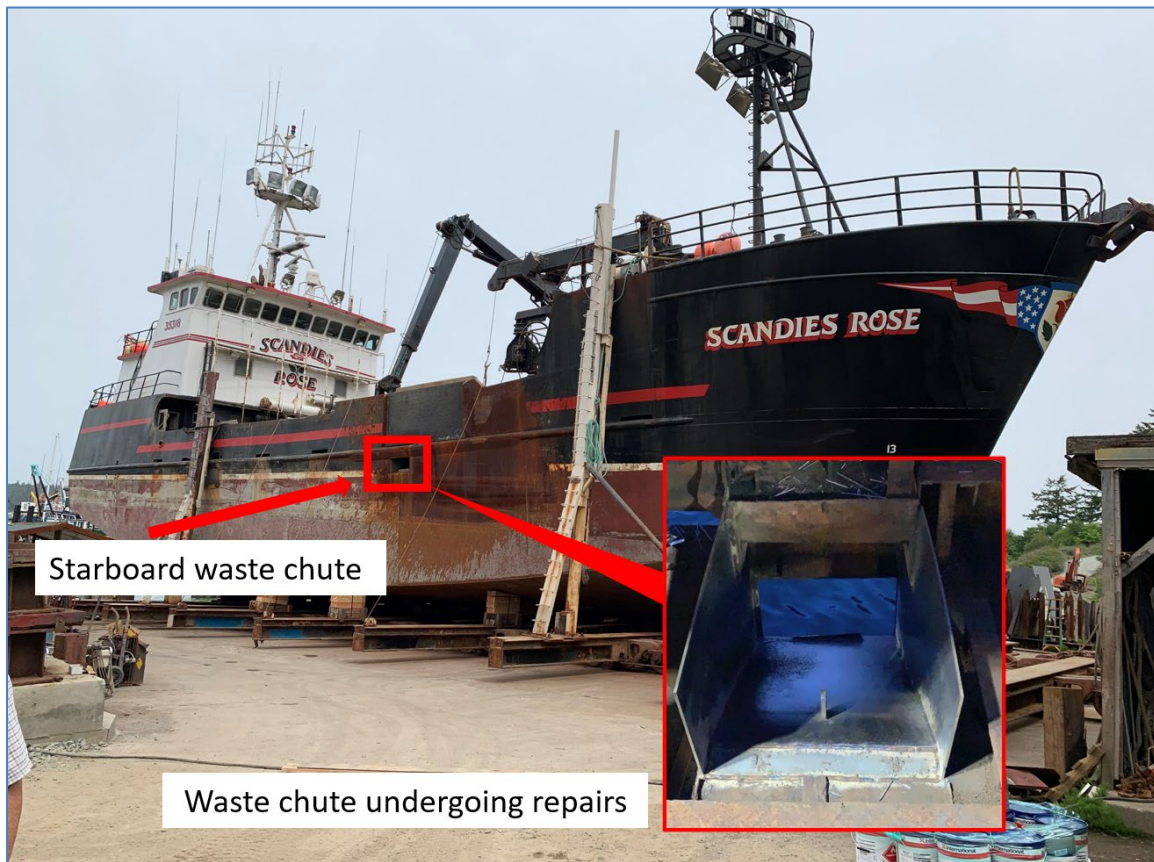
Figure 11. *Scandies Rose* on the blocks in May 2019. The starboard waste chute is highlighted, with inset photo showing waste chute undergoing repairs, as viewed from on board the vessel, looking outboard.

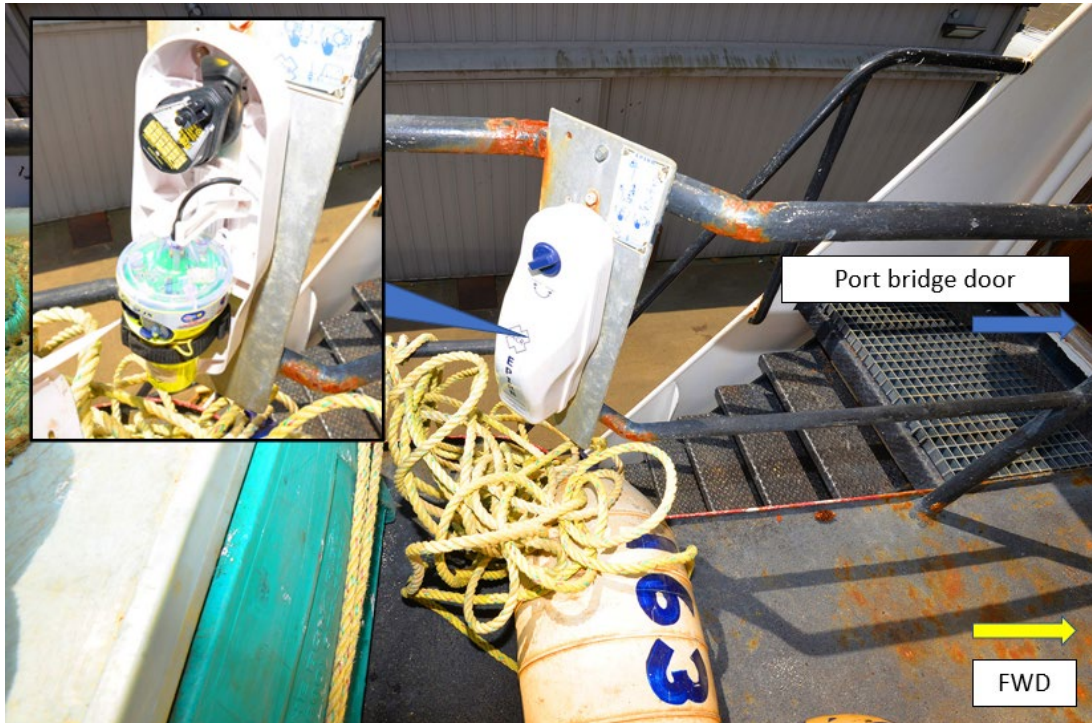
Figure 14. The *Scandies Rose* EPIRB mounted on the handrail aft of the bridge. Inset shows the float-free EPIRB with protective cover removed.

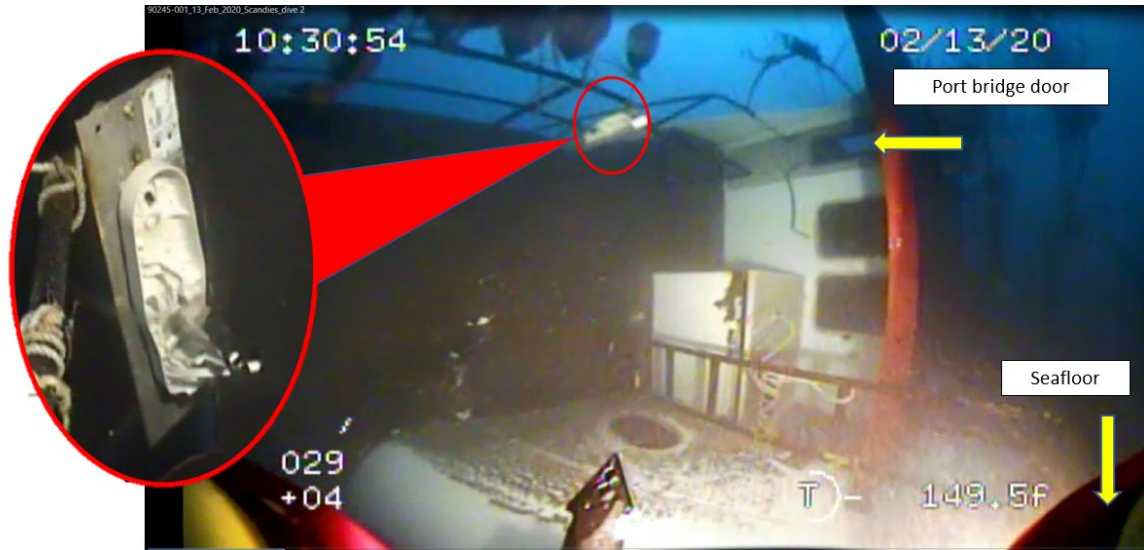
At no point after the sinking of the *Scandies Rose* was a signal received from the vessel's EPIRB. Neither of the surviving crewmembers saw the EPIRB while abandoning the vessel. The manufacturer of the EPIRB lists the unit as having an operating life of 48 hours and states that the unit is "waterproof" at 33 feet for 5 minutes. The manufacturer also states that for proper beacon operation, the antenna of the unit must have a "clear view to the sky."²⁷ The ROV survey video footage showed the empty EPIRB bracket mounted to the handrail aft of the port bridge door (see figure 15), but the EPIRB was not found.

Figure 15. Screen capture from ROV video taken of the *Scandies Rose* showing the portside third deck, aft of the bridge. Exploded view shows an empty EPIRB bracket, mounted to the port handrail.

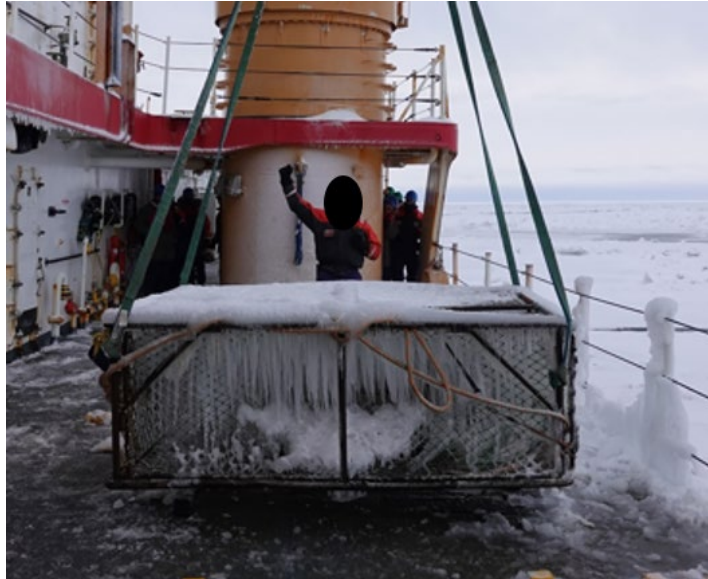
Following the sinking of the *Scandies Rose*, USCGC *Polar Star* simulated sea spray ice accumulation to observe how ice can potentially accumulate inside a crab pot. The crew used a garden hose with a mist applicator to spray fresh water over a 1,040-pound crab pot on the vessel’s deck while on patrol in the Bering Sea (see figure 23). After 72 hours, with temperatures ranging from 5°F to 15°F and variable winds, the pot weight more than tripled due to the accumulated ice, and the exact weight of the pot could not be determined because it maxed out the load cell used, which was rated for 3,000 pounds. The crew observed significant ice accumulation inside the pot, but the thickness of the ice, outside and inside the pot, was not determined.

Figure 23. Crewmembers aboard USCGC *Polar Star* weigh a crab pot following a 3-day freezing spray experiment.

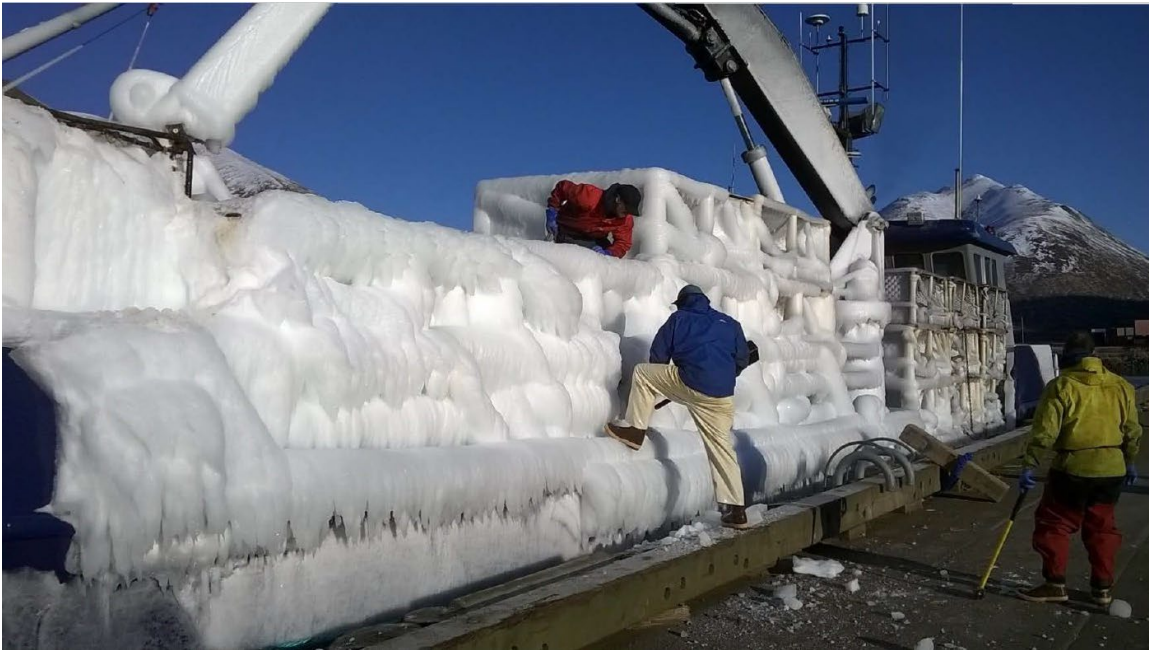
Figure 24. Ice accumulation on the fishing vessel *Sandra Five* in King Cove, Alaska, February 12, 2017. The vessel was operating the previous day in the Bering Sea in the vicinity of the *Destination* (NTSB 2018).

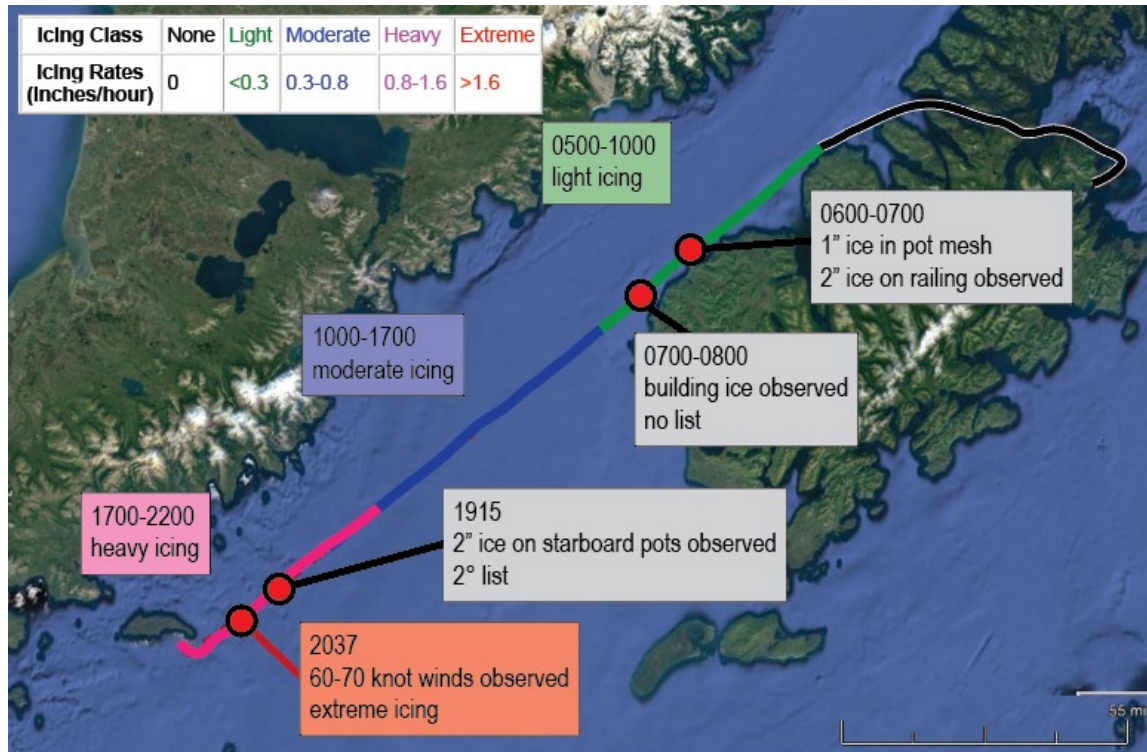
Based on the ice accretion rate obtained from the NTSB's weather model (which relied on weather conditions reported from the larger area's four weather stations) the *Scandies Rose* experienced progressively worse icing during the voyage.⁴³ Plotting the vessel's track, it is likely that the vessel first started accumulating ice around 0500 on December 31 (crew first observed icing at 0600). The vessel was then likely in light icing between 0500 and 1000, in moderate icing between 1000 and 1700, and in heavy icing between 1700 and 2200 (see figures 25 and 26). However, based on the localized weather conditions reported by the captain and crew, the *Scandies Rose* was likely experiencing ice accumulation greater than 1.6 inches per hour, which is categorized as extreme icing, over the final 2 hours of the voyage. The NTSB concludes that, based on the voyage timeline and the estimated ice accumulation over that period, the *Scandies Rose* likely accumulated between 6 and 15 inches of ice on surfaces exposed to wind and icing during the accident voyage.

Figure 26. NTSB-calculated icing conditions the *Scandies Rose* would have encountered along voyage route and observed conditions.

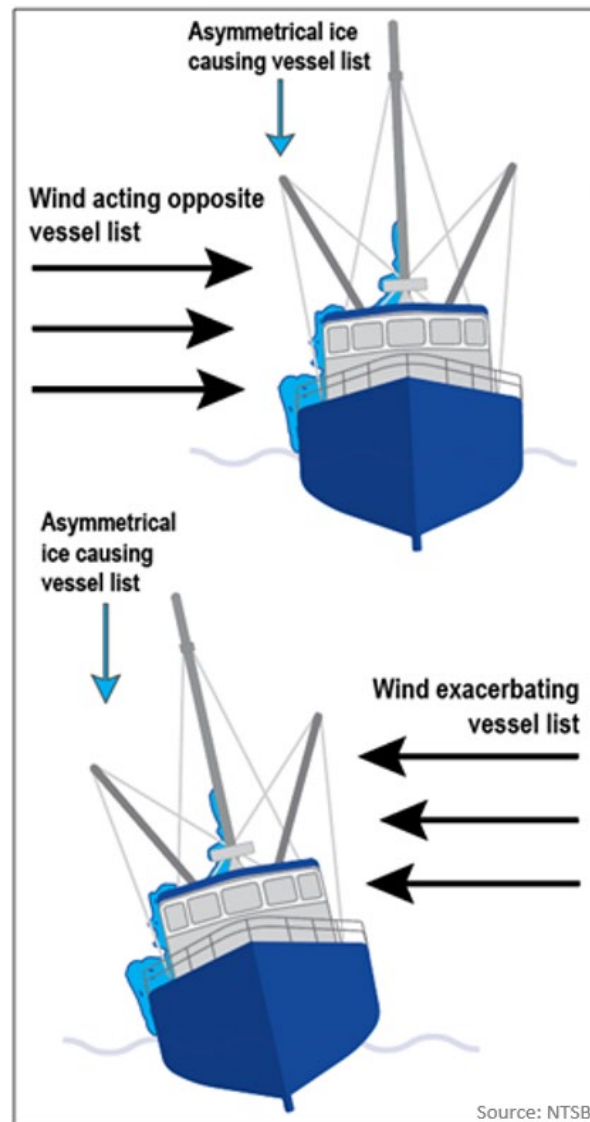
The weight of the asymmetrical icing on the starboard side of the *Scandies Rose* pot stack and structure caused the vessel to develop a starboard list, which grew worse leading up to the time of the accident. As stated earlier, the captain's course change toward Sutwik Island at 2145 brought the 60–70 knot winds onto the port

Figure 27. Diagram of ice and wind acting on the *Scandies Rose*.
