MIR-23-26

# Crane Wire Failure on Cargo Ship

## *Thorco Basilisk*

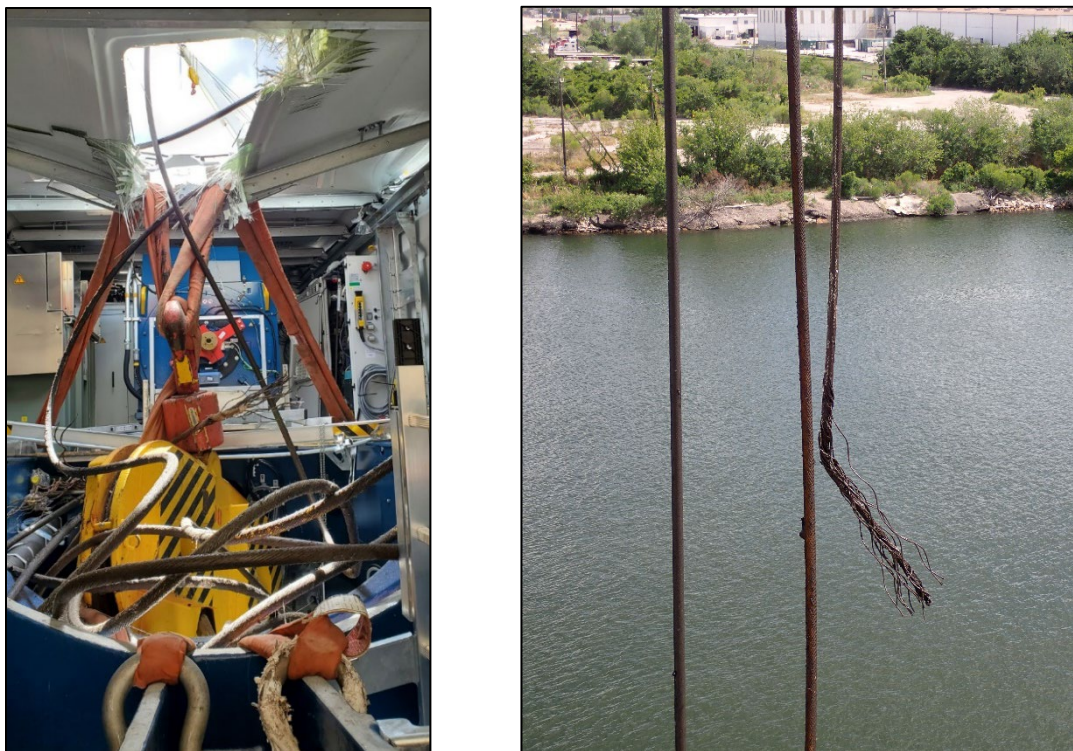
The nacelle sustained damage to its outer fiberglass housing structure and its internal components, including the yaw bearing, hydraulic unit, electrical component top boxes, transformers, and main converter. The nacelle's rear transport frame was also damaged from the impact with the tween deck.

Damages to the vessel included indentations to two of the pontoons making up the tween deck in cargo hold no. 1, including damage to the substructures and side plate in cargo hold no. 1.

**Figure 5.** Crane no. 1's block smashed into the top of the damaged nacelle (*left*) and its parted wire rope on the crane side (*right*). (Source: US Coast Guard)

Following the casualty, the *Thorco Basilisk* crew cut the parted wire rope and secured the crane until repairs could be made and new wire rope installed. A postcasualty damage survey conducted by DNV-GL directed that cargo crane no. 1 be secured and not used until the wire rope was replaced and crane no. 1 be load tested by the classification society. The *Thorco Basilisk* continued to operate using the undamaged cranes (nos. 2 and 3), calling on additional ports before arriving in Hamburg, Germany on August 30. Between August 30 and September 5, technicians from the crane manufacturer, MacGregor, inspected each of the three cargo cranes and replaced the crane wire ropes on all three cargo cranes.

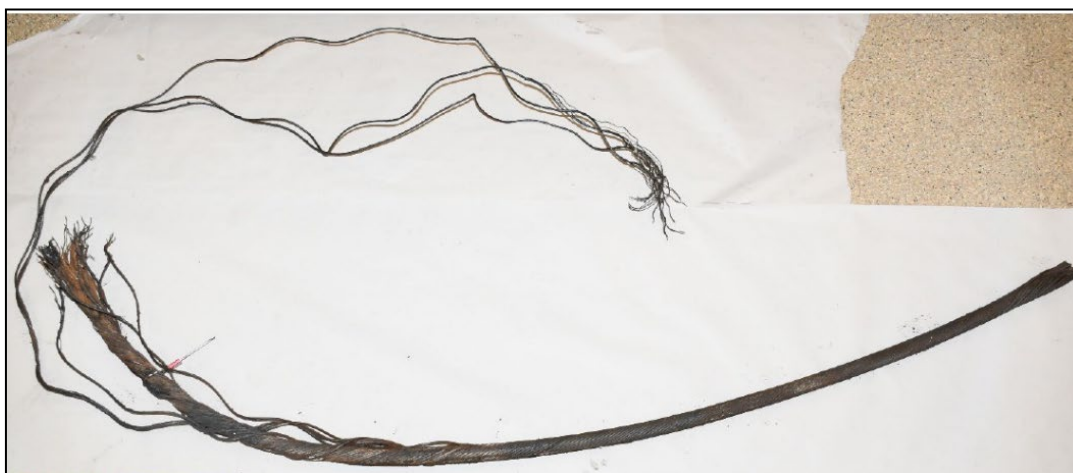
**Figure 7.** *Thorco Basilisk* parted hoisting wire rope (crane side of fracture). (Source: Engineering Systems Inc)

The resulting report concluded that the primary failure mechanism of the hoisting wire rope was corrosion and wear, followed by "monotonic ductile overload failure" of the remaining wire cross sections. The report noted that the wire rope sections exhibited "a significant level of external corrosion" with a severity rating of about 60%; a severity rating of 100% would require that the wire rope be discarded. However, because a reference diameter from when the wire rope was installed on board the *Thorco Basilisk* was unavailable, a quantitative severity rating based on uniform decrease in wire rope

diameter from wear could not be assigned. Examination of the external condition of the wire rope samples showed “obvious uniform corrosion,” and that the wires visually displayed “roughness and pitting,” with the most severe corrosion observed nearest to the fracture location. Examination of internal corrosion also revealed “uniform corrosion of internal surfaces” visible near where the wire rope became unraveled.

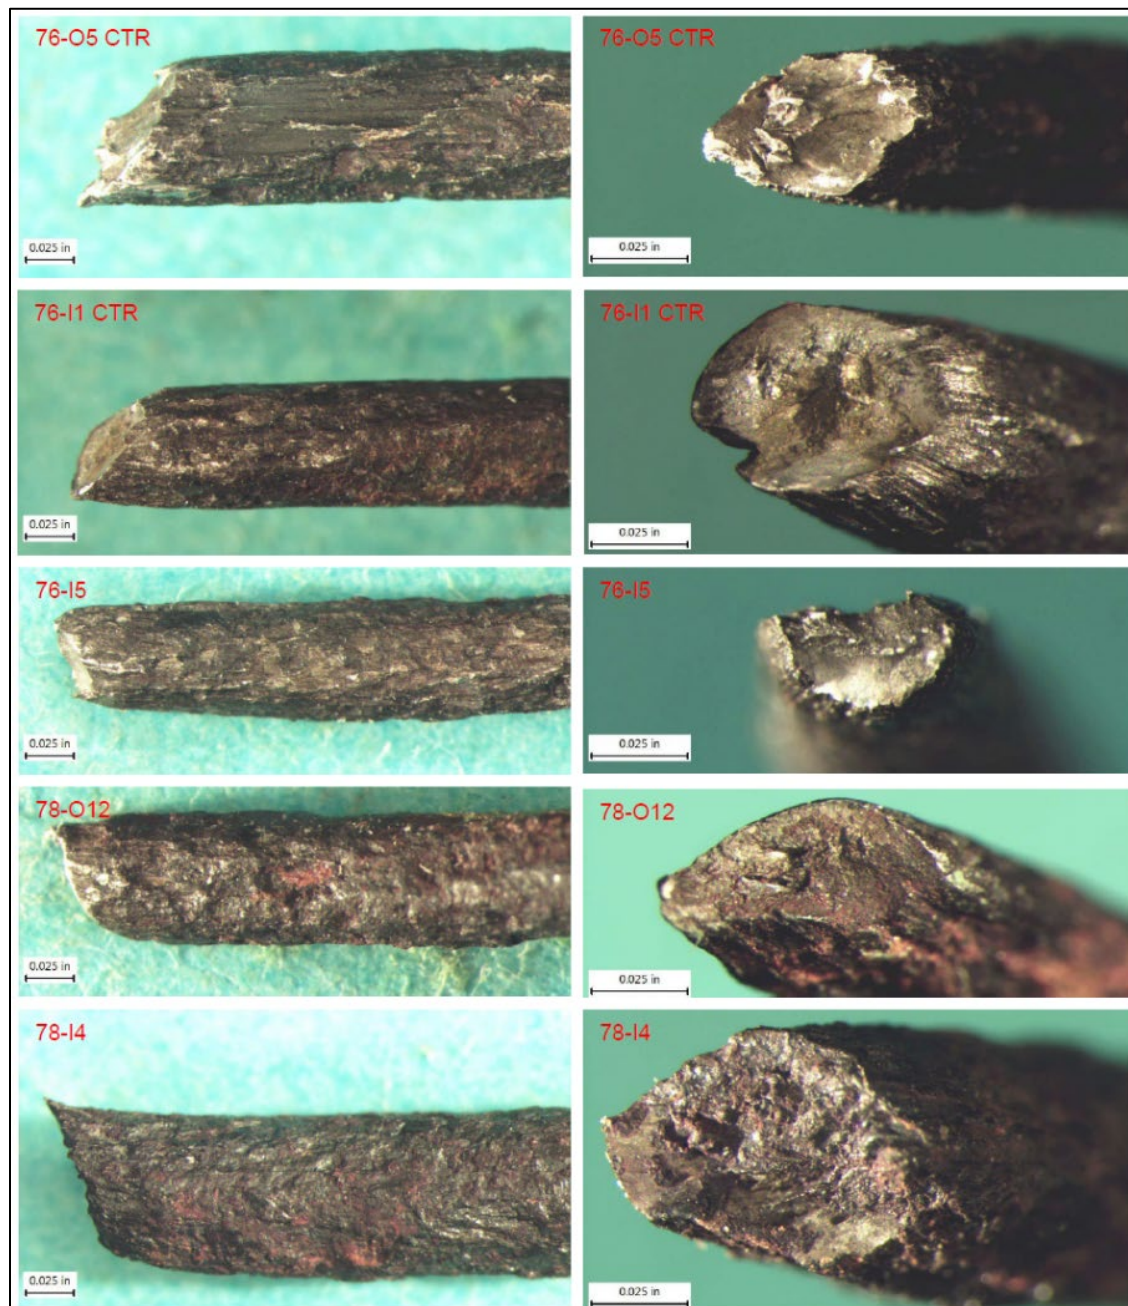
**Figure 8.** Views of wire ductile fractures from the side (*left*) and perpendicular to the fracture surface (*right*) found in strands of the failed wire rope. (Source: Engineering Systems Inc)

The report noted a localized increase of about 10% in wire rope diameter near the eye connecting to the lifting block and stated this increase would warrant discard (replacement). The report also stated that there were no broken wires on the examined segments, and the visible signs of external corrosion could not be fully appreciated (observed) until the grease was removed.

After the casualty, samples of crane no. 1's hoisting wire rope were examined to determine what had caused the wire rope to fail. The examination noted a localized increase in wire rope diameter near the eye and stated this increase would warrant discard (replacement). However, based on stevedores' and vessel crew's statements, investigators determined that the increase in diameter near the eye occurred postcasualty when the lifting block fell through the fiberglass housing of the nacelle unit and therefore had not contributed to the failure of the wire rope. The examination also found significant external corrosion, as well as roughness and pitting, and "uniform corrosion of internal surfaces" of the hoisting wire rope. This corrosion and wear caused some of the individual wires comprising the strands of the hoisting wire rope to part (fail) when crane no. 1 lifted the nacelle unit, subsequently causing the strand and then the remaining wire strands to become overloaded and fail.
