Enbridge Incorporated
Hazardous Liquid Pipeline Rupture and Release
Marshall, Michigan
July 25, 2010

NTSB/PAR-12/01
PB2012-916501

Pipeline Accident Report

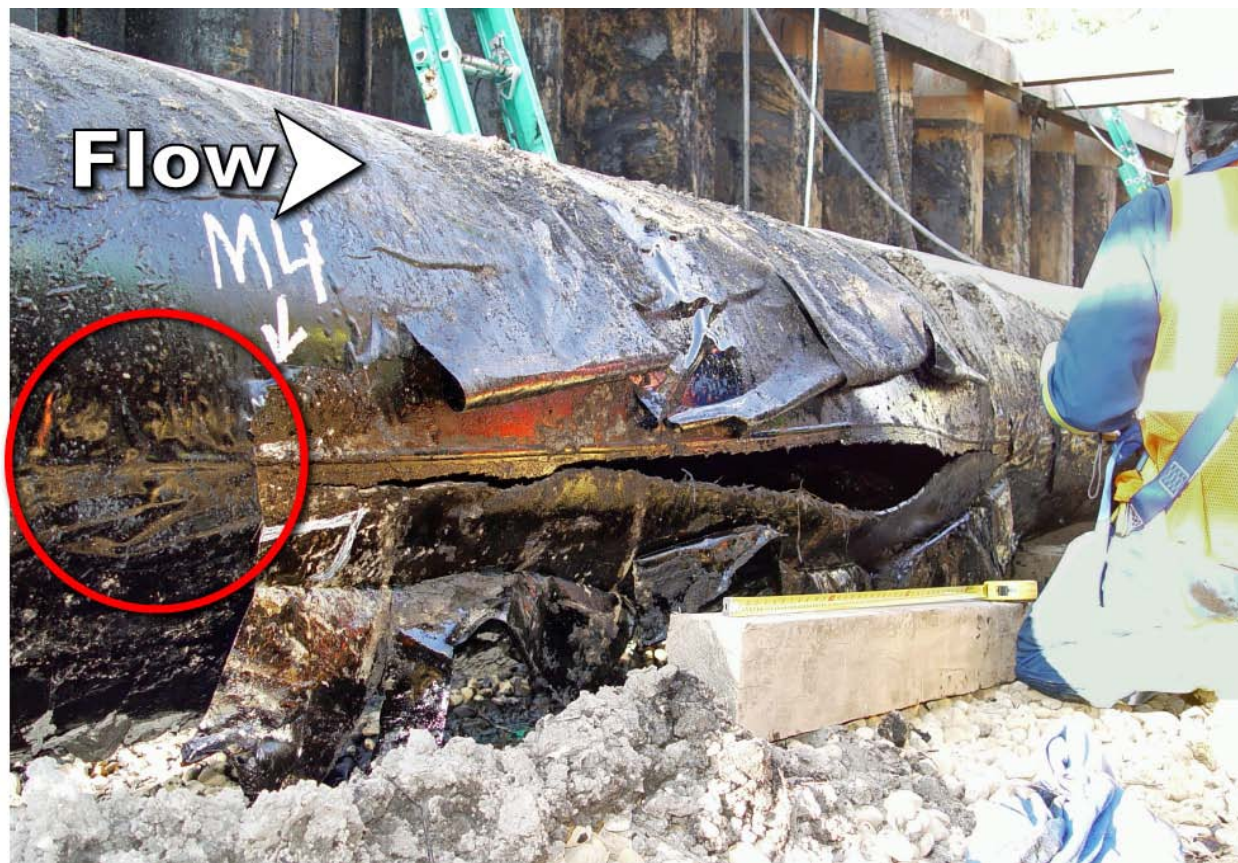
The fracture in the ruptured segment measured 6 feet 8.25 inches long and up to 5.32 inches wide. (See figure 2.) External corrosion was present along the longitudinal weld seam and in areas where the adhesive bond between the pipe and its protective polyethylene tape coating had deteriorated (disbonded). The coating was wrinkled and had separated from the pipe surface as shown in the red circle in figure 2.

Figure 2. The ruptured segment of Line 6B in the trench following the July 25, 2010, rupture. The fracture face measured about 6 feet 8.25 inches long and was 5.32 inches wide at the widest opening. The fracture ran just below the seam weld that was oriented just below the 3 o'clock position. A red circle shows a location where the coating was wrinkled and had separated from the pipe surface.

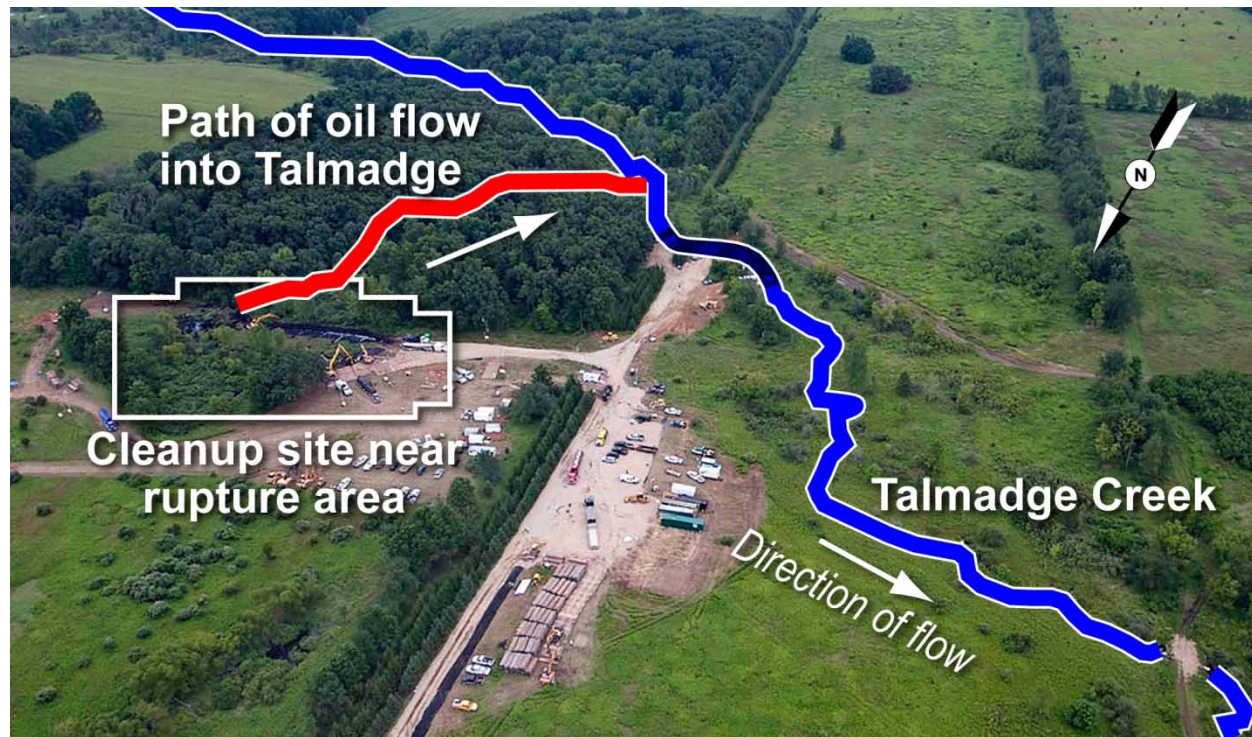
The crude oil release soaked the rupture site and the surrounding wetlands, eventually spreading to the Talmadge Creek and the Kalamazoo River. Enbridge's early response efforts were focused downstream of the rupture. Recent heavy rainfall had increased the flow of the Talmadge Creek and the Kalamazoo River, which spread the oil faster, hindering the response efforts. (See figure 3.)

Figure 3. Aerial view of the accident location showing the rupture site to the left and the Talmadge Creek flowing west toward the Kalamazoo River.

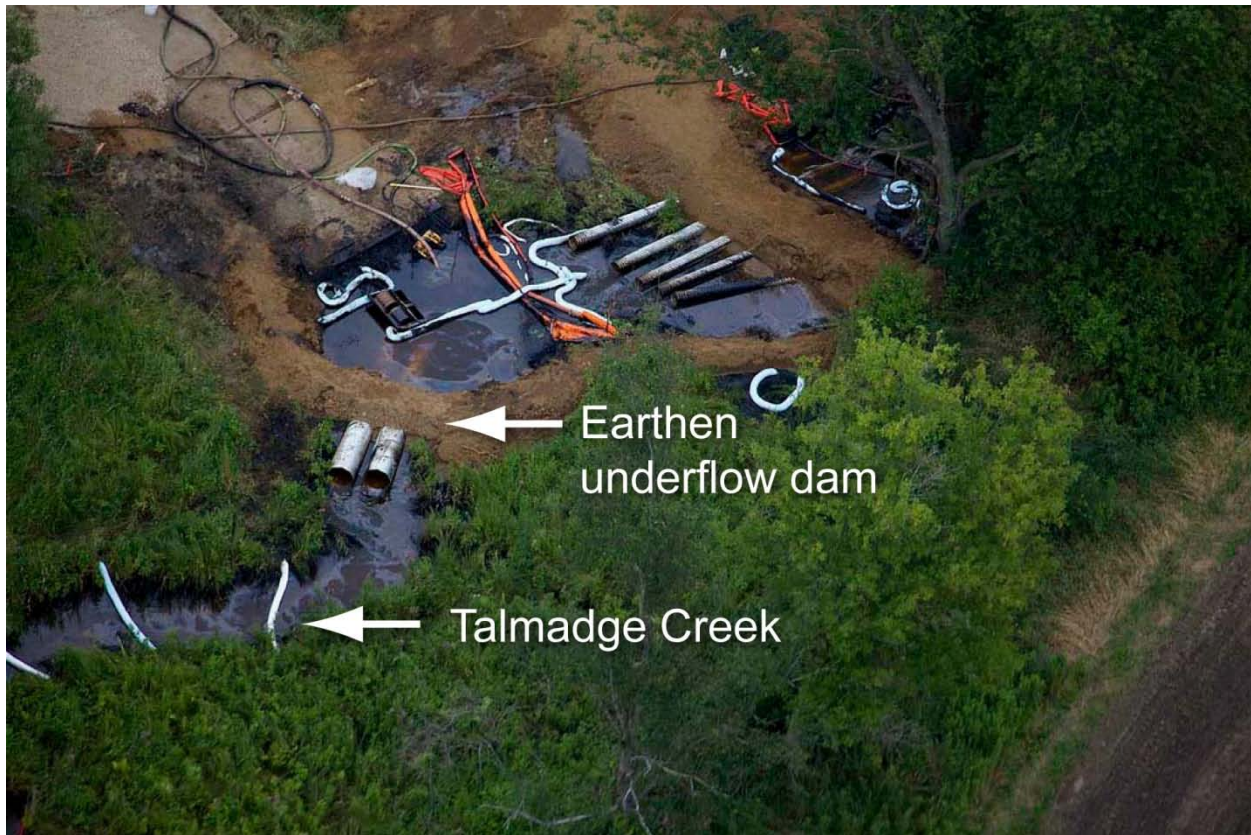
Working with a six-person crew, the Marshall PLM supervisor constructed an earthen underflow dam, which consists of a mound of soil holding back oil-contaminated water with pipes submerged on the dam side and rising toward the discharge end. The angle of the pipe allows the deeper water in the dam to flow downstream, preventing the contaminated surface waters from flowing into Talmadge Creek. (See figure 10.)

Figure 10. Underflow dam on Talmadge Creek on July 30, 2010.

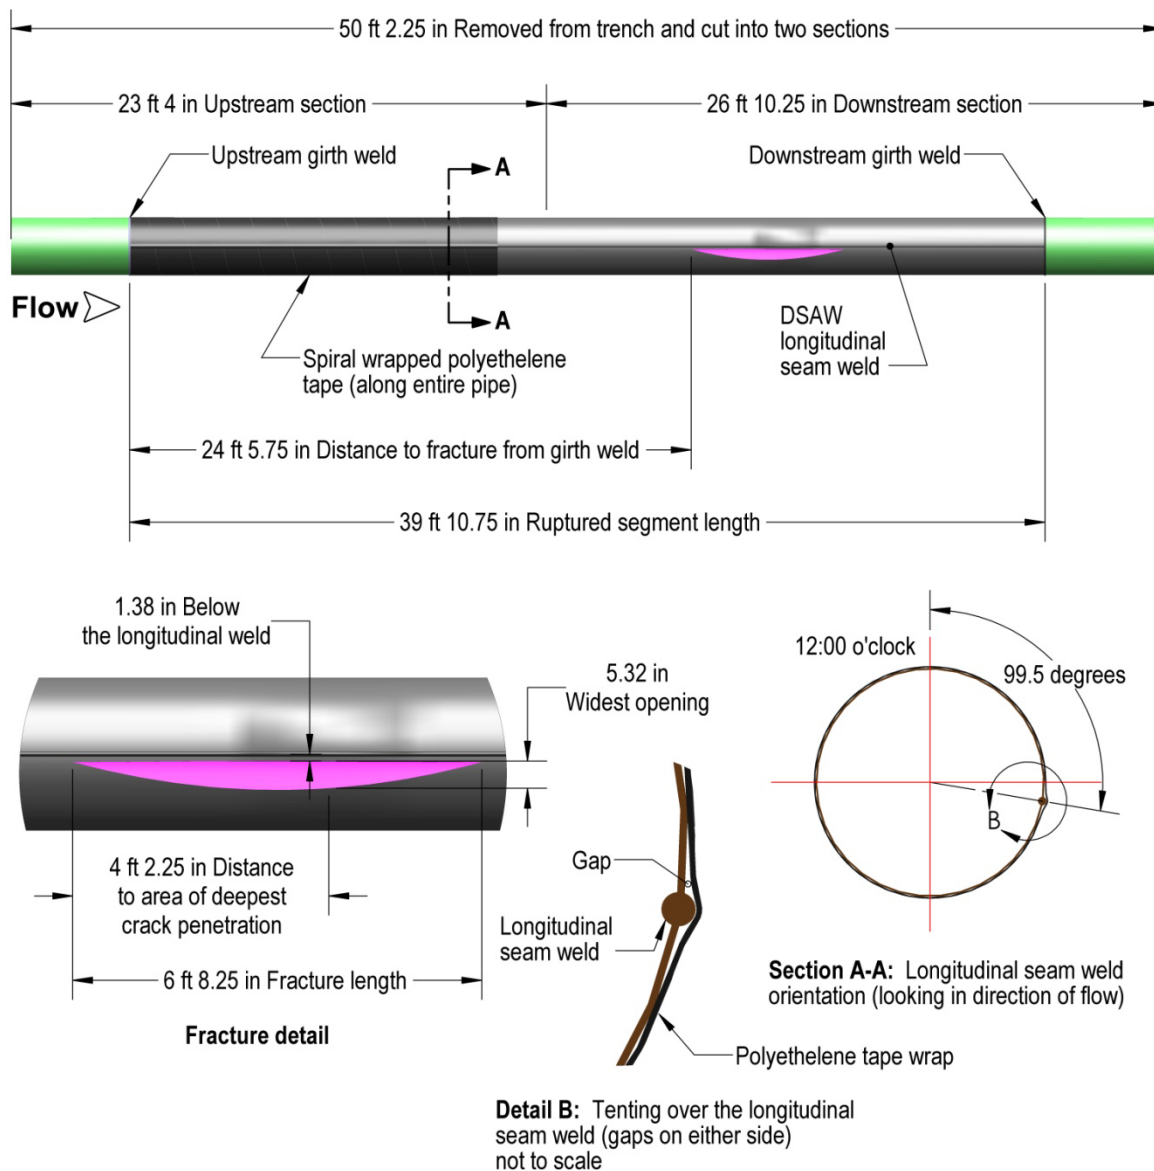
The ruptured pipe segment was 39 feet 10.75 inches long. The longitudinal seam was oriented at 99.5° clockwise.⁴³ A 50-foot length of pipe that included the rupture was removed and cut into two sections for shipping to the NTSB's Materials Laboratory for examination. The upstream section measured 23 feet 4 inches. The downstream section measured 26 feet 10.25 inches. (See figure 11.)

Figure 11. Line 6B ruptured segment showing upstream and downstream sections used for Materials Laboratory examination. Detail B shows tented coating over the longitudinal seam weld.

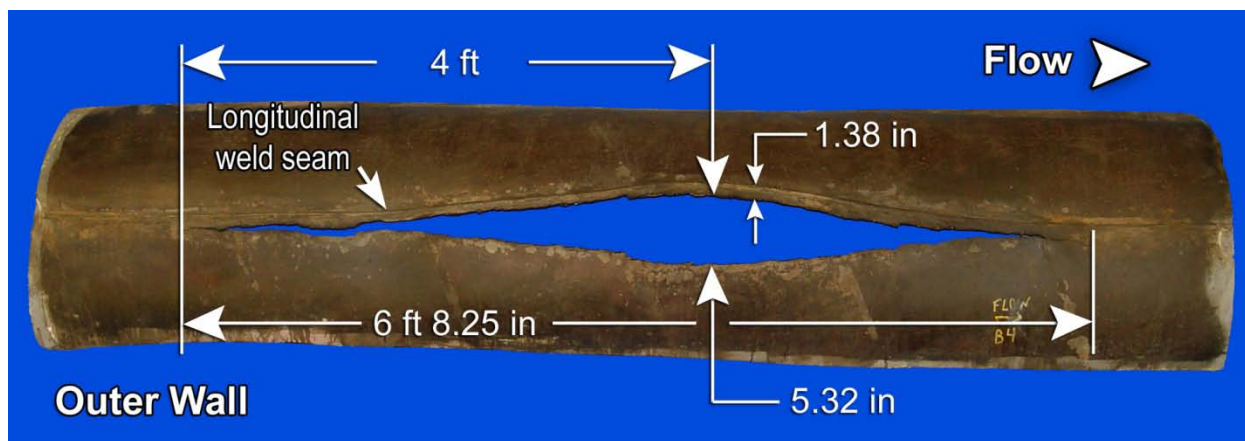
The fracture measured 6 feet 8.25 inches in length with the upstream end of the fracture located 24 feet 5.75 inches away from the upstream girth weld. The widest point along the fracture measured 5.32 inches and was about 4 feet from the upstream end of the rupture. The upper fracture face at the widest opening was measured at 1.38 inches below the longitudinal seam weld away from the heat-affected zone, with this offset ranging from 0.5 to 1.5 inches below the longitudinal weld seam for the length of the fracture face. (See figure 12.)

Figure 12. The outside surface of the pipe looking at the fracture area cut for lab examination.

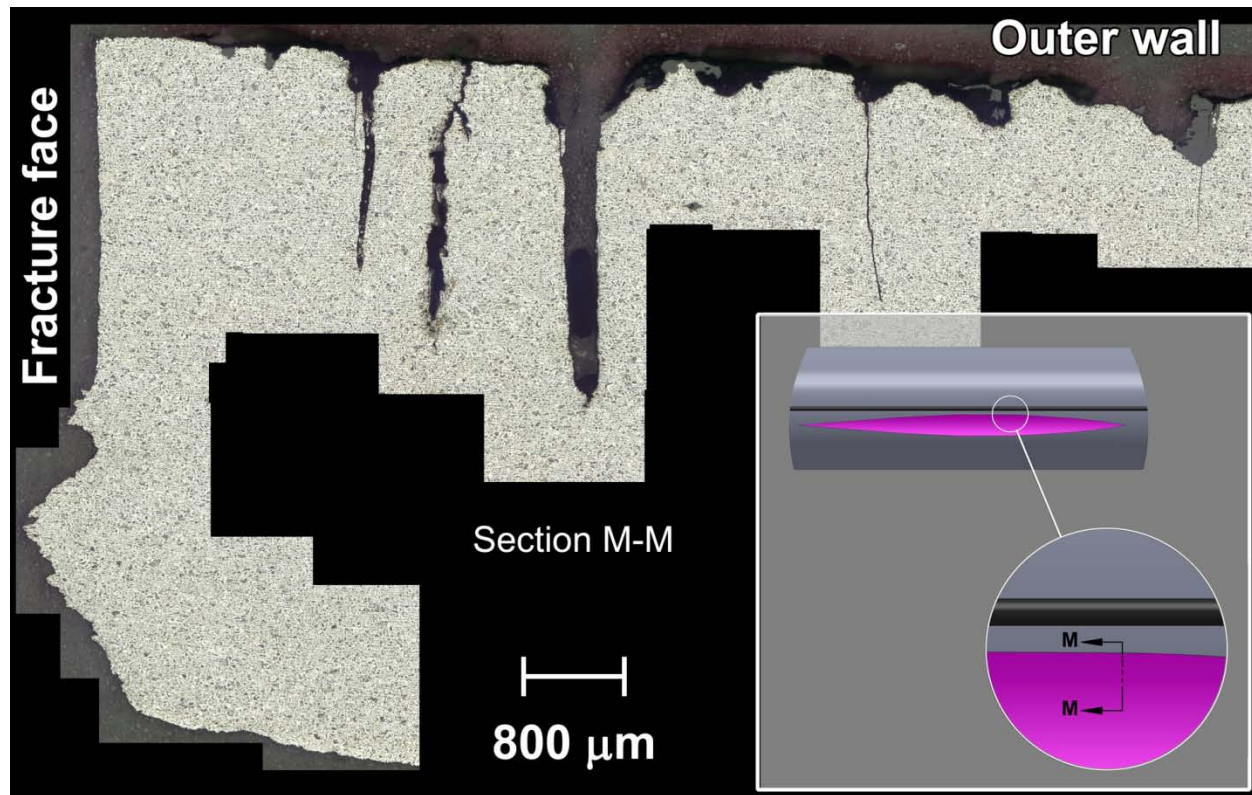
A cross-section through the fracture was prepared as shown in figure 15. The preexisting crack portion of the fracture showed a transgranular⁴⁹ fracture path with limited crack branching, consistent with near-neutral pH SCC or corrosion fatigue. Multiple closely spaced and parallel secondary cracks (with transgranular propagation paths and limited crack branching) emanated from corrosion pits on the outside wall near the fracture face, also consistent with corrosion fatigue or near-neutral pH SCC. The deepest secondary crack extended through about 43 percent of the wall thickness.

Figure 15. Transverse section through the top of the fracture showing multiple parallel cracks emanating from corrosion pits on the outside surface.
