Loss of Control on Approach
Colgan Air, Inc.
Operating as Continental Connection Flight 3407
Bombardier DHC-8-400, N200WQ
Clarence Center, New York
February 12, 2009

NTSB/AAR-10/01
PB2010-910401

Aircraft Accident Report

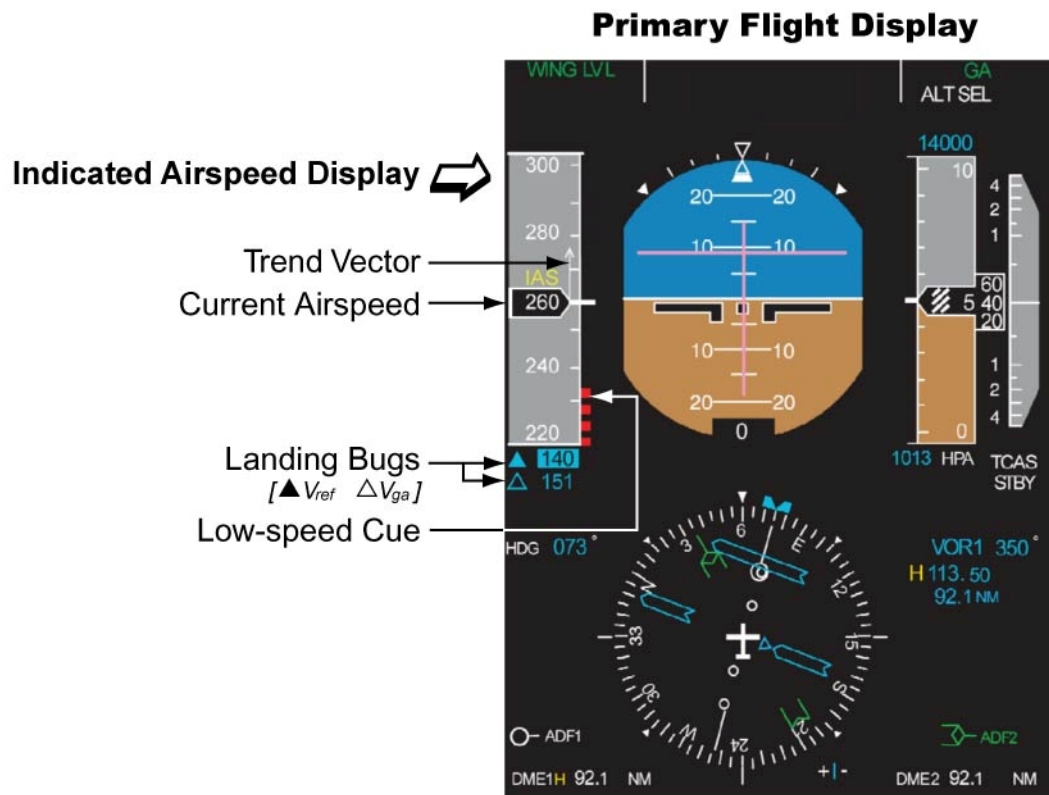
Figure 1. Q400 Indicated Airspeed Display

A low-speed cue is shown as a red and black vertical bar that extends from the bottom right of the vertical scale. The low-speed cue warns pilots of an inappropriately low airspeed for the airplane configuration or operating condition.⁴⁷ If the airplane’s IAS is less than or equal to the IAS at the top of the low-speed cue, the stick shaker activates. Also, the numbers on the IAS display change from white to red, providing pilots with another visual warning of an inappropriately low airspeed. Figure 1 shows the IAS digital display on the Q400 PFD.

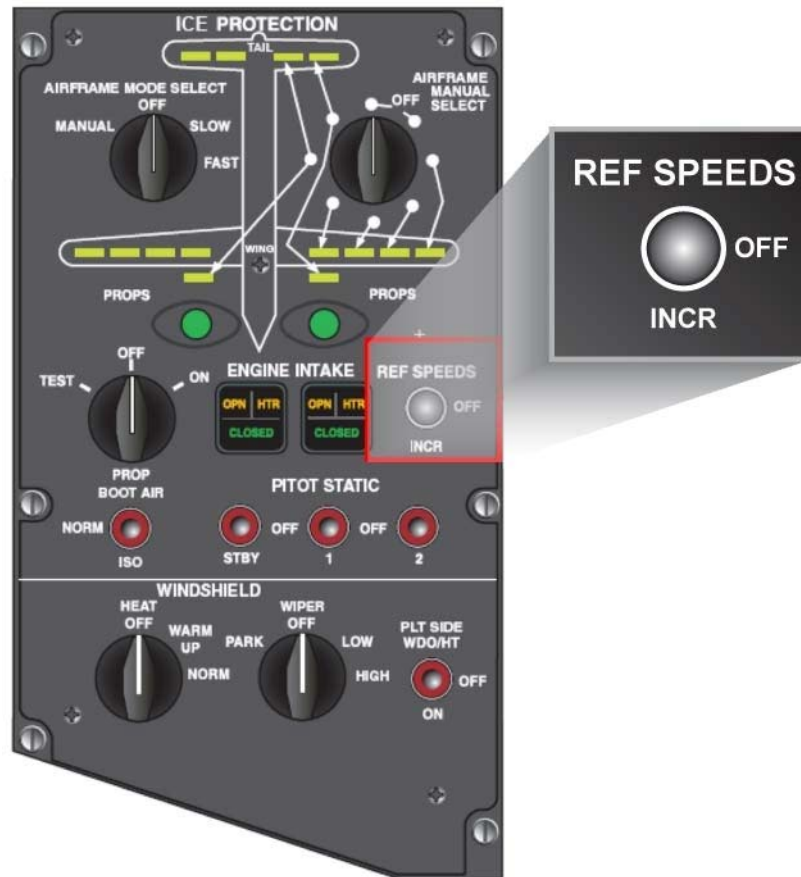
Figure 2. Q400 Reference Speeds Switch

The ice protection panel, which is located on the overhead panel on the captain's side of the cockpit, includes a "REF SPEEDS" switch that can be set to the INCR (increase) or OFF positions, as shown in figure 2. During the May 2009 public hearing on this accident,⁴⁸ an engineering manager from Bombardier stated that the ref speeds switch, when set to the increase position, advances the stall warning so that the stick shaker would activate at a lower AOA;⁴⁹ as a result, the airplane would have the same performance margins relative to the stall speed during operations in icing conditions as it would have with a clean (no ice accretion) configuration (and the ref speeds switch set to the off position). The engineering manager also stated that, because the stick shaker would activate at a lower AOA with the ref speeds switch set to the increase position, the flight crew would need to increase landing airspeeds between 15 and 25 knots depending on the flap setting (to remain above the stall warning threshold).

The Bombardier Q400 AFM, section 4.7.2, Ice Protection Procedures, dated July 13, 2005, stated that the ref speeds switch was to be in the increase position before entering icing conditions and in the off position after the airplane is aerodynamically clean (that is, all ice is removed from the visible leading edges and wing tips). The Q400 AFM also cautioned that a stall warning might occur if airspeed was not increased before the ref speeds switch was selected to the increase position. The ref speeds switch on the accident airplane was found in the increase position.

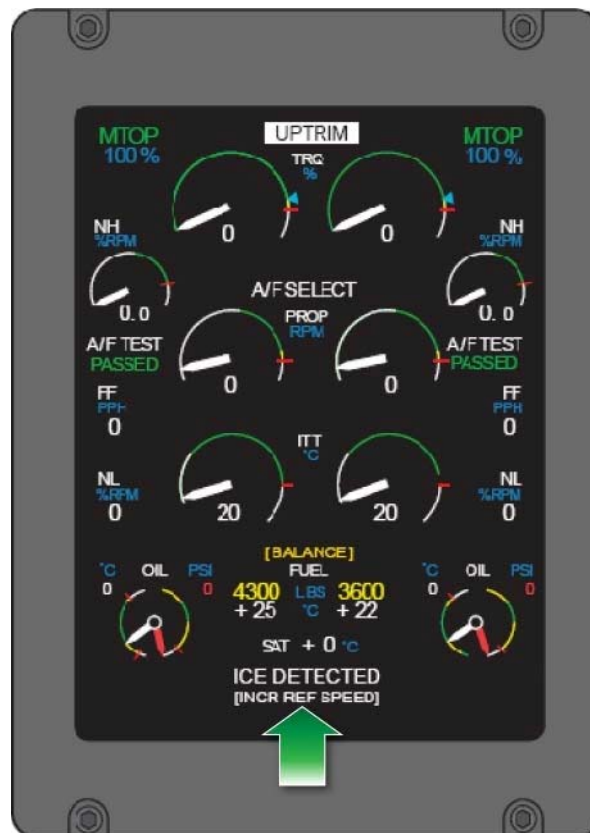
Figure 3. Q400 Engine Display Showing Ice Detected and Increased Reference Speeds Message

The Q400 engine display shows an “ICE DETECTED” message, as shown in figure 3, when one or both ice detector probes detect more than 0.5 millimeter (0.02 inch) of ice. The message appears in reverse video (black letters on a white background) for 5 seconds if the ref speeds switch has already been set to the increase position. After the 5-second period, the message appears in normal video (white letters on a black background, as shown in figure 3) when ice is detected and the ref speeds switch remains set to the increase position. If the ref speeds switch is set to the off position when ice is detected, the message flashes with yellow letters on a black background until the switch is turned to the increase position. In addition, when the switch has been selected to the increase position, an “INCR REF SPEED” message (also shown in figure 3) appears in normal video, regardless of whether ice has been detected.
