Capsizing and Sinking of
Commercial Fishing Vessel *Scandies Rose*
Sutwik Island, Alaska
December 31, 2019

Marine Accident Report

NTSB/MAR-21/02
PB2021-100924

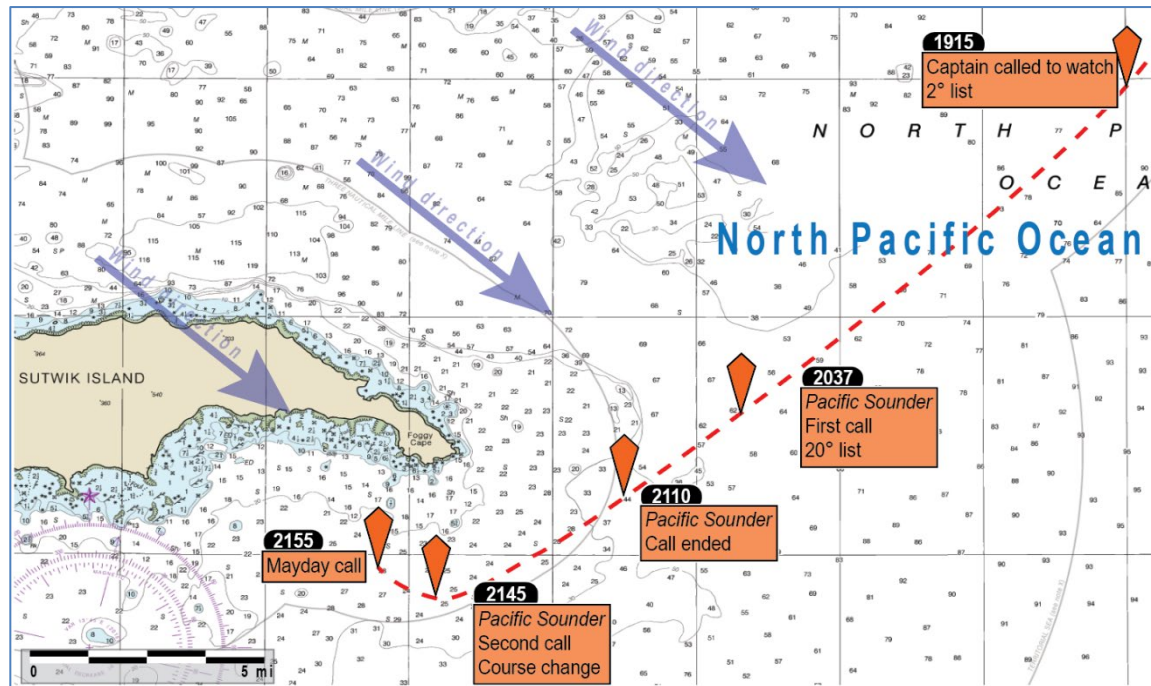
Figure 5. *Scandies Rose*'s positions over last 3 hours before mayday call.

About 2145, automatic identification system (AIS) data show that the *Scandies Rose* was about 2.5 miles south of Sutwik Island (see figure 5). The vessel had turned about 50° to starboard and held a northwesterly course in the direction of Sutwik Island's southern bay. After completing his work in the engine room, the captain of the *Pacific Sounder* called the captain of the *Scandies Rose* back. He said that the captain's “tone had changed” from their previous conversation. He said that the captain of the *Scandies Rose* said, I don't know how this is going to go,” and that his vessel's “list had gotten a lot worse.” The captain of the *Pacific Sounder* said that he had never heard that level of stress in the voice of the *Scandies Rose* captain before.

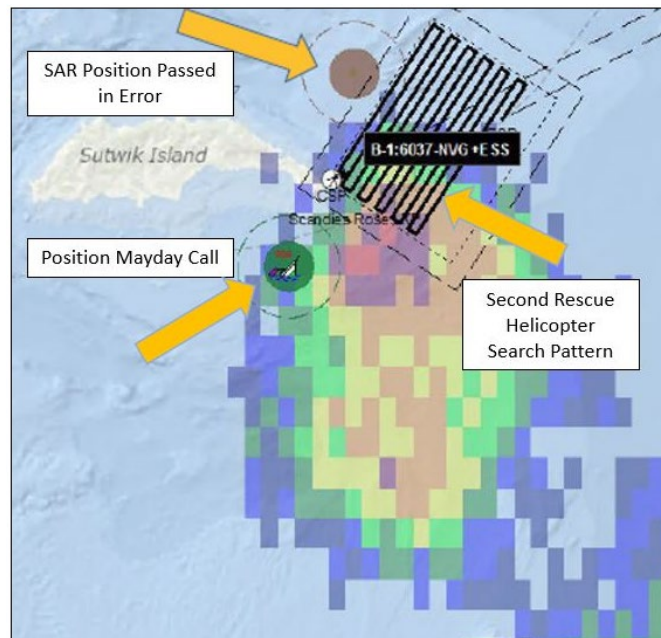
The coordinates where the two survivors were found had been reported back to the Coast Guard command center from the MH-60 via the on-scene C-130. These coordinates were used to generate a search pattern that was provided to the second helicopter. However, the location information relayed to the command center was incorrect and was north of Sutwik Island (7.8 miles north of the location of the captain's mayday transmission). The second helicopter arrived on scene at 0534 and followed the search pattern created from the northern coordinates, until it departed the scene at 0640 (see figure 7). It wasn't until after the second helicopter departed the scene to return to base that SAR command determined that the survivor recovery location coordinates were passed through the C-130 to the command center with an error, and that the second helicopter's search pattern was too far north. All subsequent searches were based off the coordinates from the captain's mayday call and the updated coordinates of the liferaft.

Figure 7. Second rescue helicopter search area, based off position passed in error. Purple and red indicates the highest-probability areas for locating survivors.

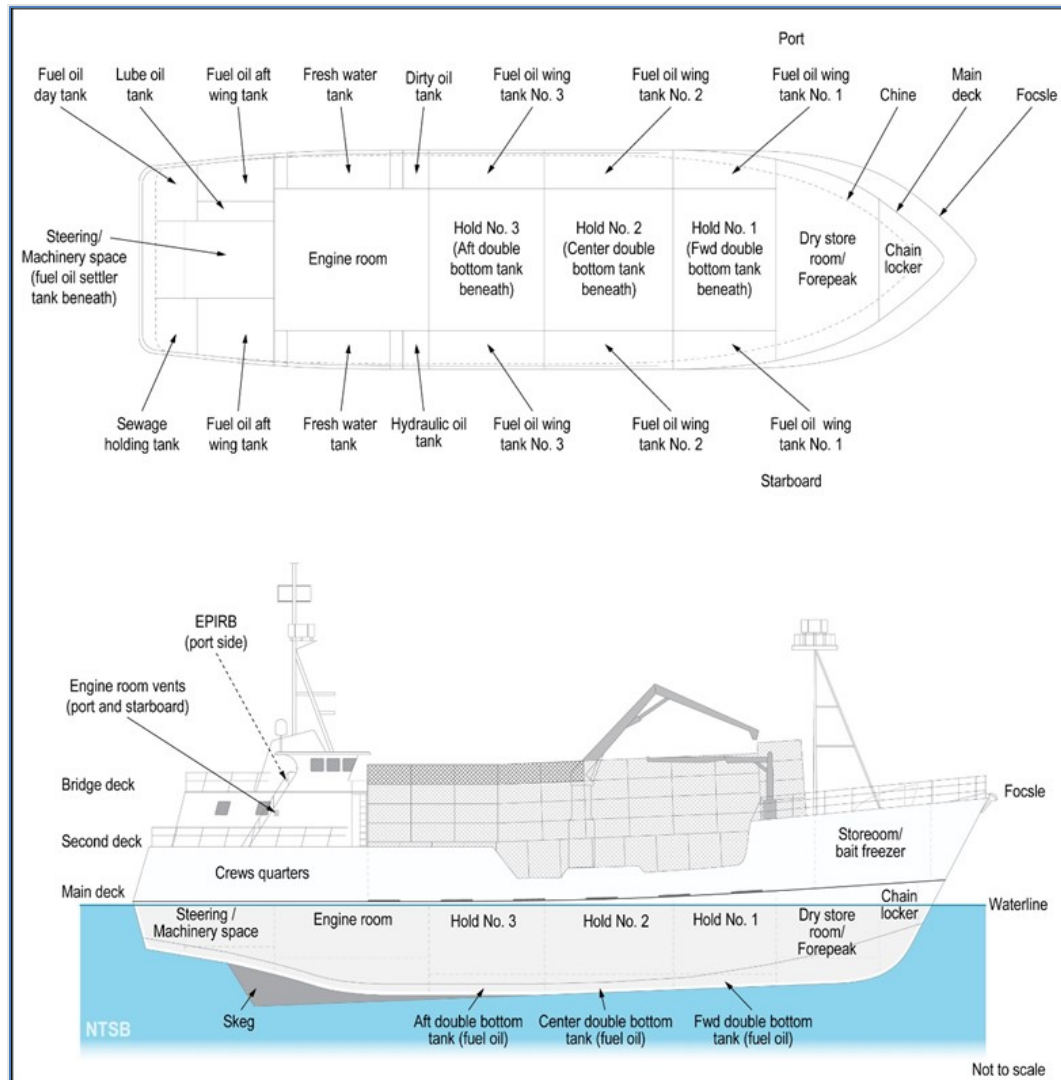
The *Scandies Rose* bow plating was 5/8-inch steel, and the hull and deck plating were 1/2-inch steel. Figure 10 shows the vessel’s layout. The hull had a nearly flat bottom and vertical sides. The bow was raked and there was a transom stern, a single hard chine, and a centerline skeg.²¹ A former crewmember referred to the *Scandies Rose* as a “tank”

Below the main deck, starting at the bow, was a ballast tank, followed by the anchor chain locker and a dry stores room, also called the forepeak. Next aft were three crab tanks: floodable holds used to store the catch. Aft of these tanks were the vessel’s engine room and machinery space, housing the vessel’s propulsion equipment and other machinery associated with the operation of the vessel. The aft-most space was a steering gear room. Four sets of port and starboard outboard fuel tanks ran the length of the vessel. Double-bottom fuel tanks were positioned underneath the holds but were not typically used and were empty during the accident voyage. Two pipe alley voids ran down the port and starboard side of the vessel, from just aft of the chain locker to the engine room. They were accessed from bolted hatches located in the forepeak and engine room. It could not be determined whether these hatches were open or closed at the time of the accident. The engine room and forepeak space were equipped with float-type bilge alarms that would alarm locally and on the bridge when activated. The floodable holds were not equipped with bilge or slack tank alarms, or level indicators.

Figure 10. *Scandies Rose* simple plan and profile views similar/approximated to accident voyage.

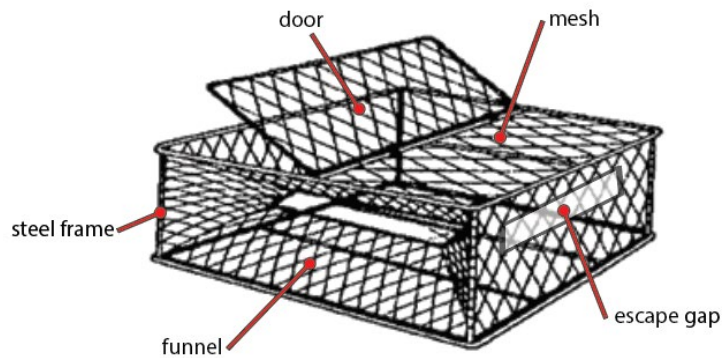
The *Scandies Rose* departed Kodiak on the casualty voyage with a pot stack consisting of 195 combination crab pots (see figure 12). Each pot was 7 feet by 8 feet by 34 inches. Combination pots vary in weight; while the 2019 stability instructions assumed a pot weight of 835 pounds, when the *Scandies Rose* underwent a Coast Guard safety compliance check (SCC) in October 2019, a sample of the combination pots on board weighed 863, 799, and 800 pounds.²⁴

The combination crab pots were stacked about nine rows fore and aft and four across, which took up the exterior main deck space of the vessel and reached up to 20 feet high above the deck. The majority of pots were stacked five high, except in front of the starboard bridge conning station where the pots were only stacked four high so that the crew's vision would not be completely obstructed. The first level (tier) of pots was positioned on their sides to facilitate easier access by the crew when fishing. The pots were secured to the vessel with chains but were not covered by a tarpaulin. There was no access tunnel for the crew underneath the pots, so the crew would have to climb over the stack to reach the storeroom and focsle at the bow of the vessel.

Figure 12. An example of a king crab pot similar to the ones used on the *Scandies Rose*. Escape gaps are often fitted into pots and traps to make sure that undersize fish or crustaceans, especially lobster and rock lobster, are not taken.

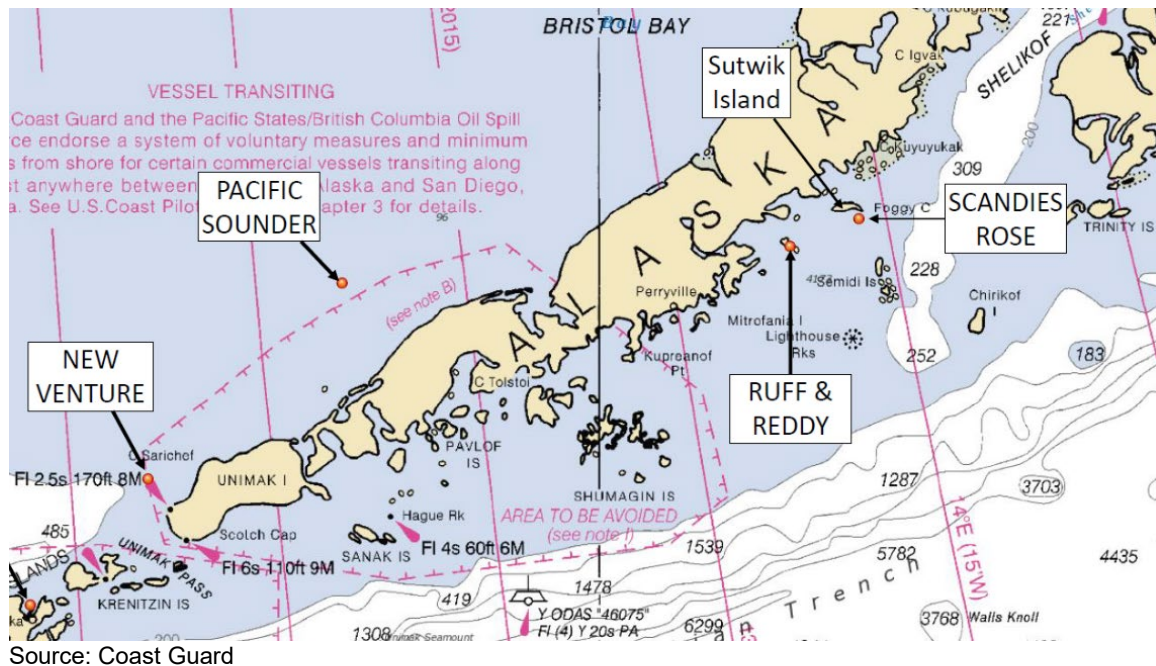
Figure 17. Vessel positions relative to the *Scandies Rose* at approximately the accident time.

Pacific Sounder. The captain of the *Pacific Sounder* stated that, during the accident timeframe, his crew was experiencing a 45-knot northwest wind and 15- to 20-foot seas at their location north of the Alaska Peninsula. Up to one-half foot of ice had accumulated on various parts of the vessel, and it took them 2 hours to clear all the ice off the vessel. He had heard the weather report around 0600 on December 31 for worsening weather conditions and started setting pots around 0900 to avoid ice accumulation. By 2100, they had set all their pots and were in heavy freezing spray conditions.

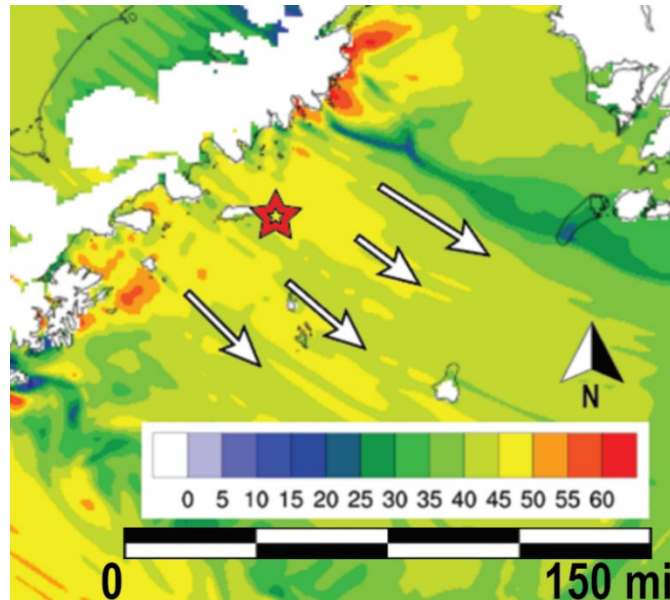
Weather Simulation. To validate the weather forecasts and further investigate the potential for williwaws, the NTSB ran a Weather Research and Forecasting (WRF) model.³⁰ The model used observational and model weather information to simulate the weather conditions along the Alaska Peninsula surrounding the time of the accident. The simulation indicated wind increasing with time, with sustained winds between 40 and 55 knots near the accident site at the accident time. (Wind gusts were not calculated.) Higher windspeeds were coming from the bays and passes in the lee of the Alaska Peninsula (red and orange on figure 18).

Figure 18. NTSB weather model showing near-surface wind in knots at 2100. The *Scandies Rose*'s approximate location is marked by a star. White arrows show estimated wind direction.

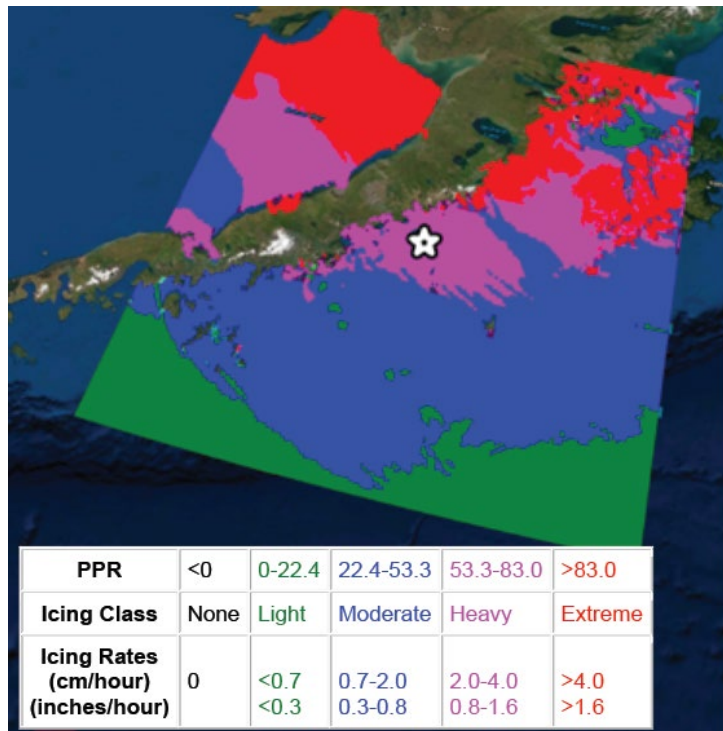
Figure 20. Modeled sea spray ice accretion values for the accident area on December 31, 2020, at 2200. The approximate accident location is marked by a star.

Using data from the NTSB weather model, the NTSB estimated the amount of sea spray ice accretion (measured in inches per hour) at times and locations along the *Scandies Rose*'s trackline. At the time of the sinking, about 2200 on December 31, the vessel was in an area that the NTSB weather model calculated as experiencing heavy sea spray ice accretion of up to 1.6 inches per hour (see figure 20).

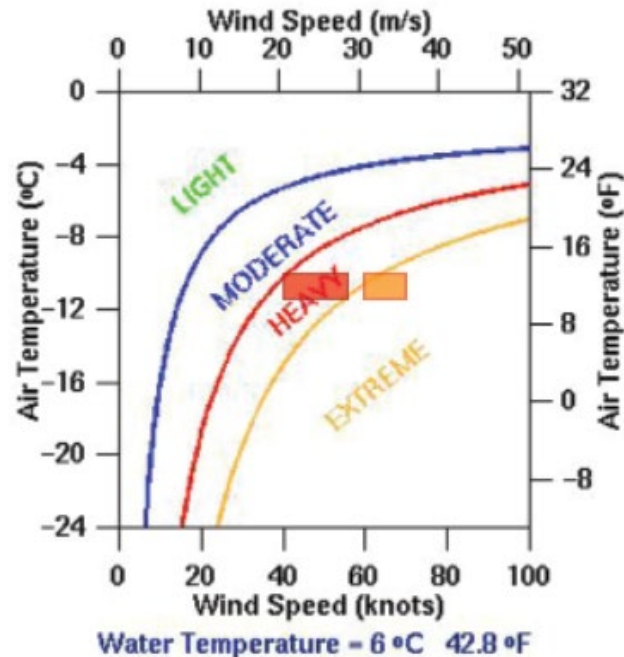
Based on the ice accretion rate obtained from the NTSB's weather model (which relied on weather conditions reported from the larger area's four weather stations) the *Scandies Rose* experienced progressively worse icing during the voyage.⁴³ Plotting the vessel's track, it is likely that the vessel first started accumulating ice around 0500 on December 31 (crew first observed icing at 0600). The vessel was then likely in light icing between 0500 and 1000, in moderate icing between 1000 and 1700, and in heavy icing between 1700 and 2200 (see figures 25 and 26). However, based on the localized weather conditions reported by the captain and crew, the *Scandies Rose* was likely experiencing ice accumulation greater than 1.6 inches per hour, which is categorized as extreme icing, over the final 2 hours of the voyage. The NTSB concludes that, based on the voyage timeline and the estimated ice accumulation over that period, the *Scandies Rose* likely accumulated between 6 and 15 inches of ice on surfaces exposed to wind and icing during the accident voyage.

Figure 25. Overland (1990) sea spray ice accretion potential for water temperature of 6.0°C. The weather conditions from 1700 to 2200 obtained from the weather model are noted in red and are primarily in the “heavy” portion of the graph. The weather conditions observed by the captain during the last 2 hours, about 2000 to 2200, are noted in orange and are primarily in the “extreme” portion of the graph.

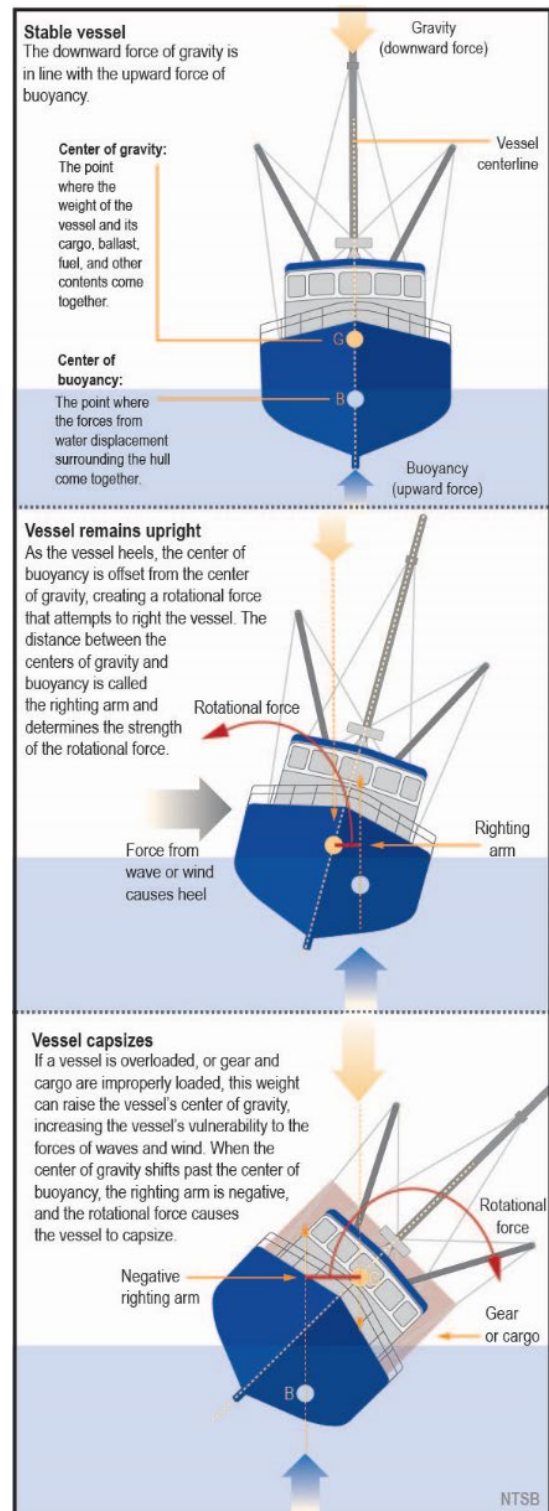
Figure 28. Principles of stability.

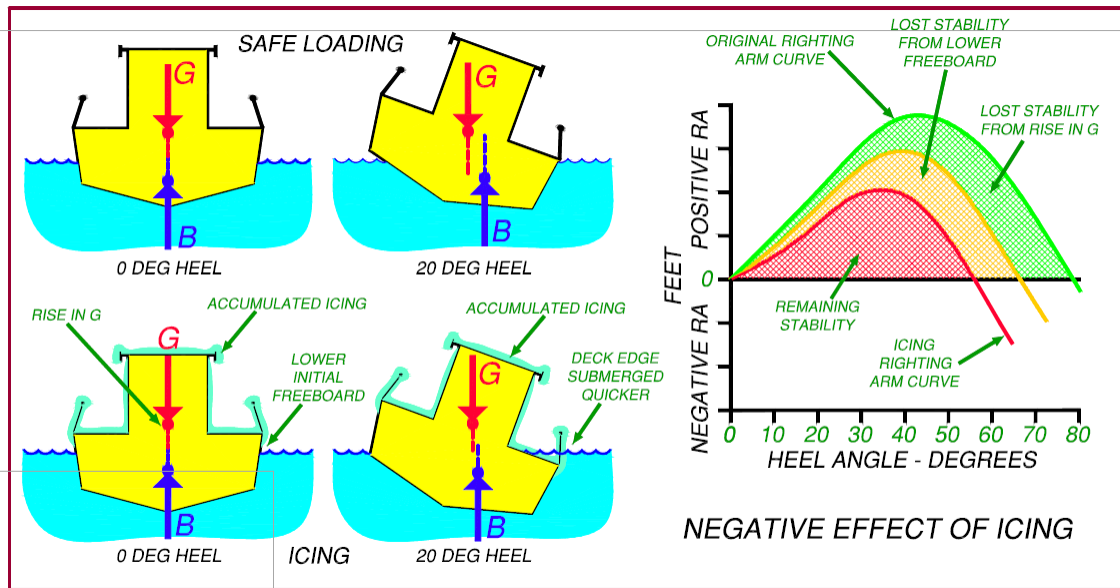
The loss of stability from ice may go unrecognized because, similar to overloading a vessel, initial stability levels at small angles of heel are only slightly reduced, which the crew may not notice as the vessel heels at smaller angles and returns. However, initial stability does not indicate the vessel's overall stability, as shown in a righting arm curve, which icing can significantly reduce. For example, a vessel that could return from a heel of 80° without the added weight of ice can capsize at lesser heel angles, such as 60°, as shown in figure 29.

Figure 29. Icing effect diagram from *A Best Practices Guide to Vessel Stability*, page 49.

The *Best Practices Guide to Vessel Stability* recommends corrective actions when icing conditions are encountered, including keeping freeing ports clear of ice to allow rapid draining of water off the decks.

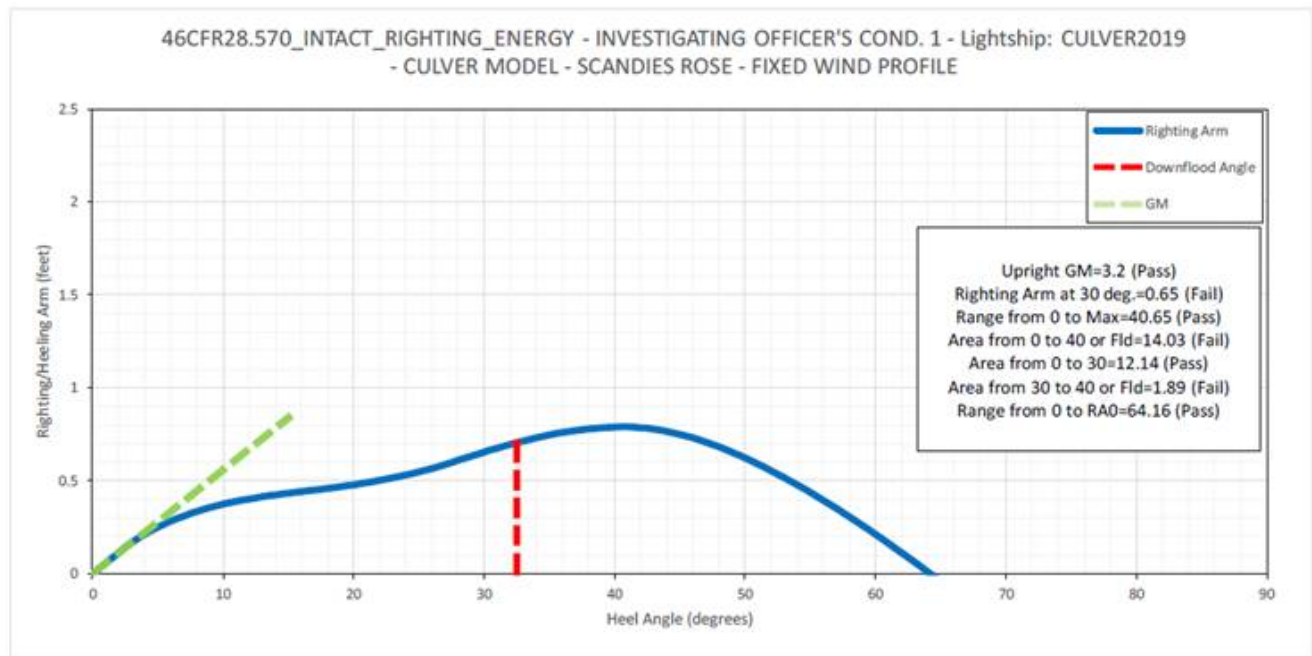
Figure 30. IO Condition 1, with 195 pots (ranging from 835, 844, 856 pounds) in tiers different than MSC Large Pots (4 tiers, 87, 39, 39, 30)

Loading Condition: Accident Voyage, Coast Guard Investigating Officer's Estimate

Pots: 195 (ranging from 835, 844, 856 pounds) (Pots different than MSC "large" pots)

Pot Stack: 4 tiers (pots per tier: 87, 39, 39, 30)

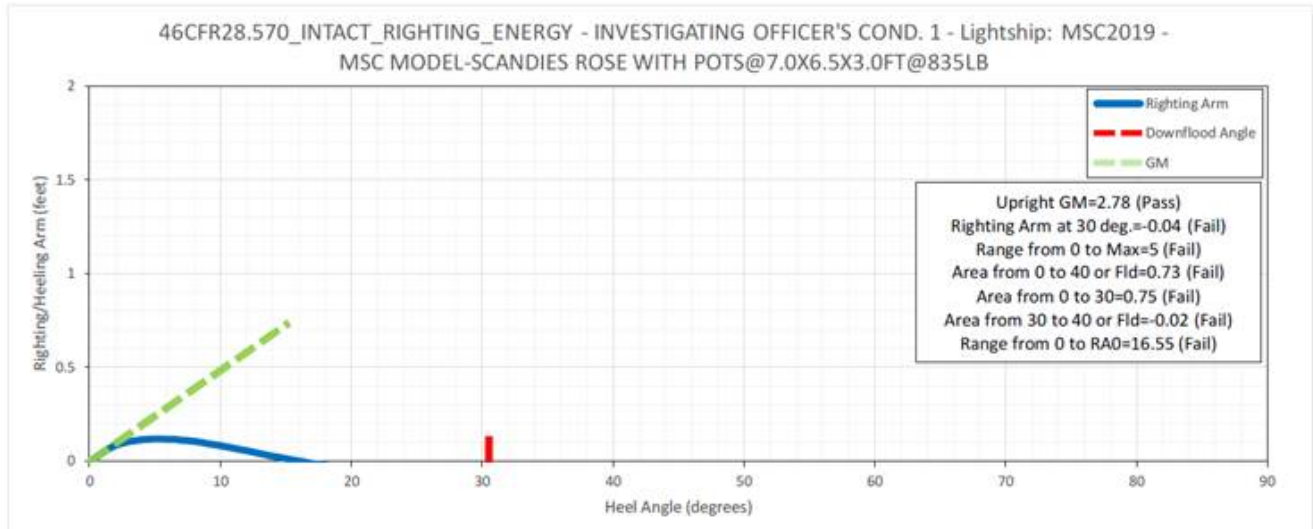
Figure 31. IO Condition 1, with 195 “small” 835 lb.-pots (4 tiers- 98, 44, 44, 9)

Loading Condition: Accident Voyage, Coast Guard Investigating Officer’s Estimate

Pots: 195 (“small” 835-pound pots)

Pot Stack: 4 tiers (pots per tier: 98, 44, 44, 9)

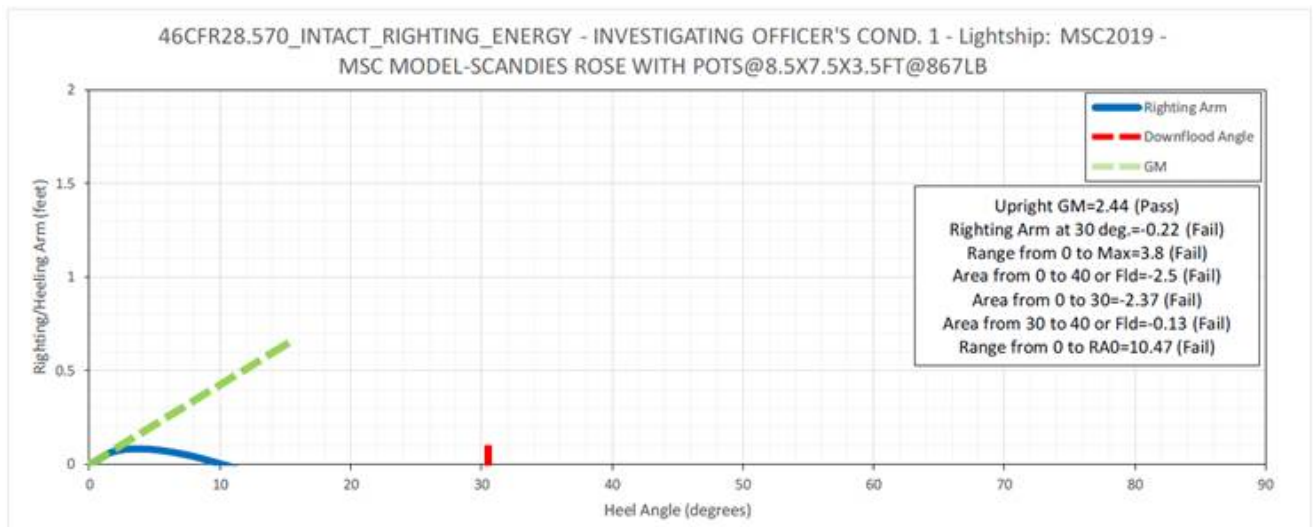
Figure 32. IO Condition 1, with “large” 867 lb.-pots (5 tiers, 72,32, 32, 32, 27)

Loading Condition: Accident Voyage, Coast Guard Investigating Officer’s Estimate
