MIR-23-26

# Crane Wire Failure on Cargo Ship

## *Thorco Basilisk*

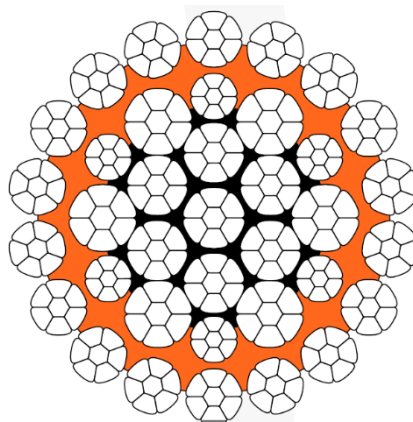
VEROPE manufactured the hoisting wire rope used on crane no. 1 and classified it as "VEROTOP-P left hand lang's lay wire rope."<sup>3</sup> The wire rope was 1.5 inches (38 millimeters) in nominal diameter, constructed of 37 strands with seven wires per strand, with a plastic-coated core. In 2008, a sample of the wire rope (later installed on the *Thorco Basilisk*) was tested to a breaking strength of 1,374 kilonewtons, or 140 metric tons (154 US tons).

**Figure 6.** Cross-section diagram of wire rope used on board *Thorco Basilisk* showing strands, with plastic-coated core shown in orange. (Source: Verope Technical Brochure)

The crane manufacturer stated that the wire rope, as originally installed, had a safety factor of 4.44 at the crane's 80-metric-ton SWL. The hoisting wire rope had been used since its installation on board the *Thorco Basilisk* in 2013, or for about 9 years (DNV-GL Standard, DNV-ST-0377, Shipboard Lifting Appliances, specified the maximum
