Enbridge Incorporated
Hazardous Liquid Pipeline Rupture and Release
Marshall, Michigan
July 25, 2010

NTSB/PAR-12/01
PB2012-916501

Pipeline Accident Report

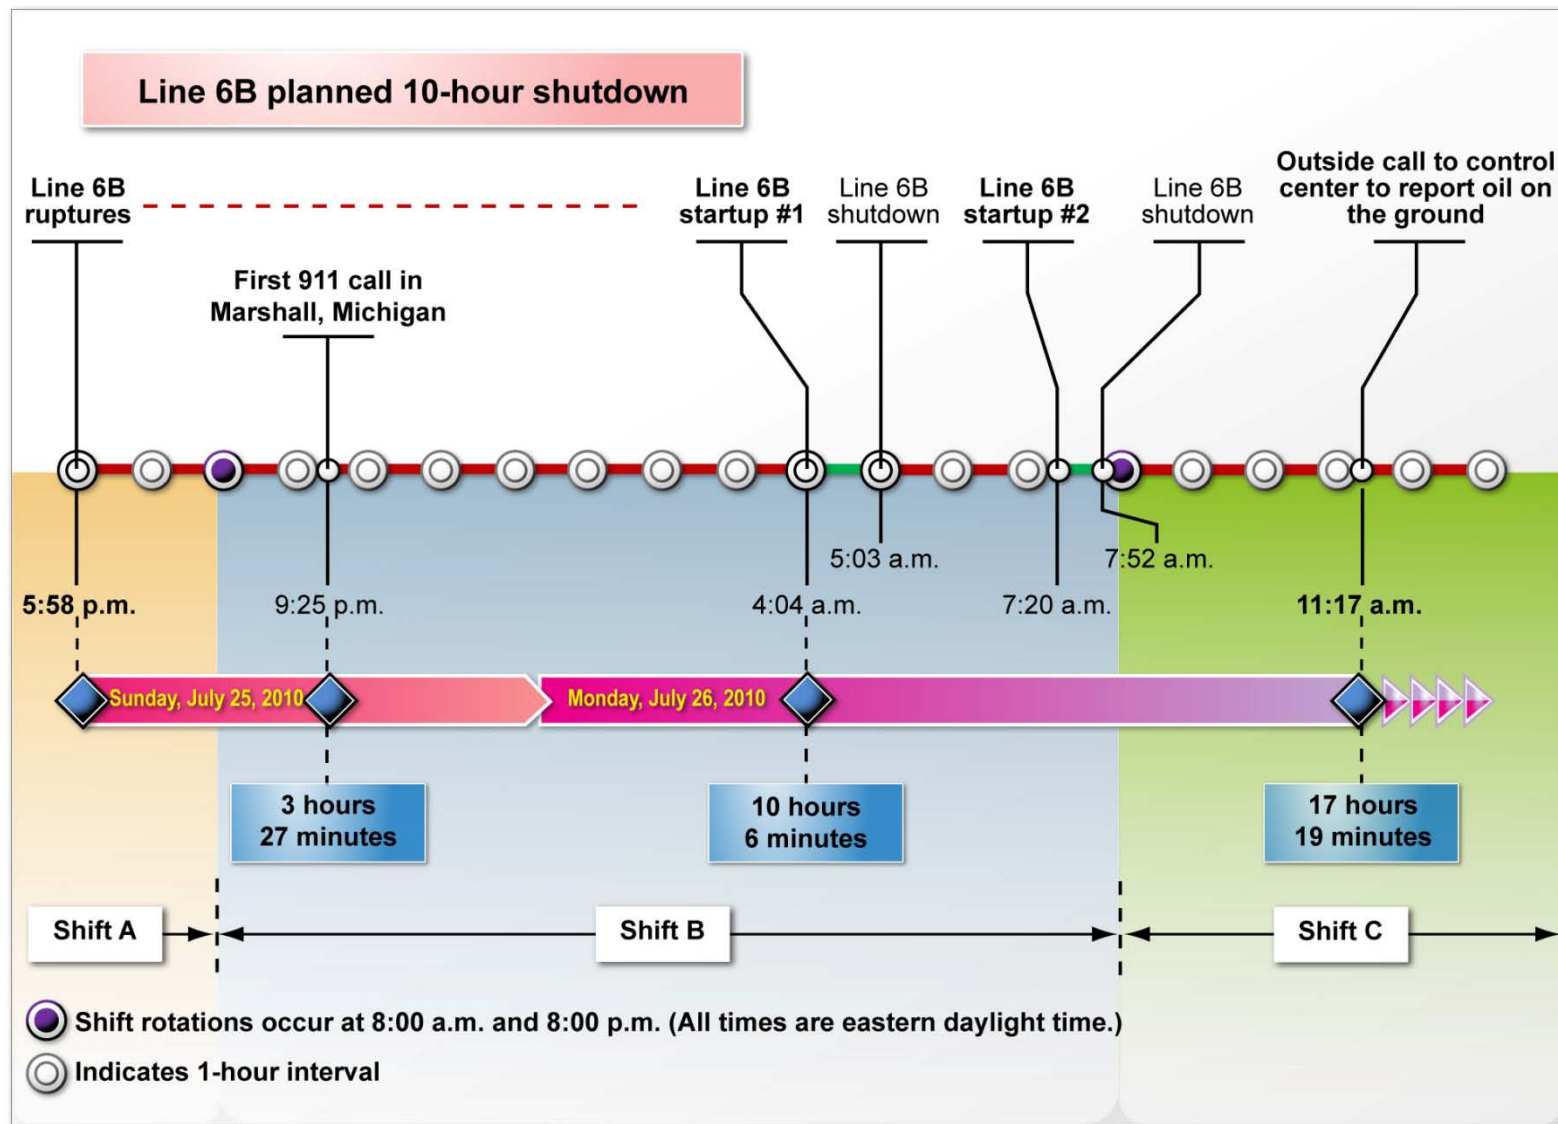
Figure 5. Key events timeline of the Line 6B rupture in Marshall, Michigan, showing the events from the time of rupture on July 25, 2010, to the time of discovery on July 26, 2010.

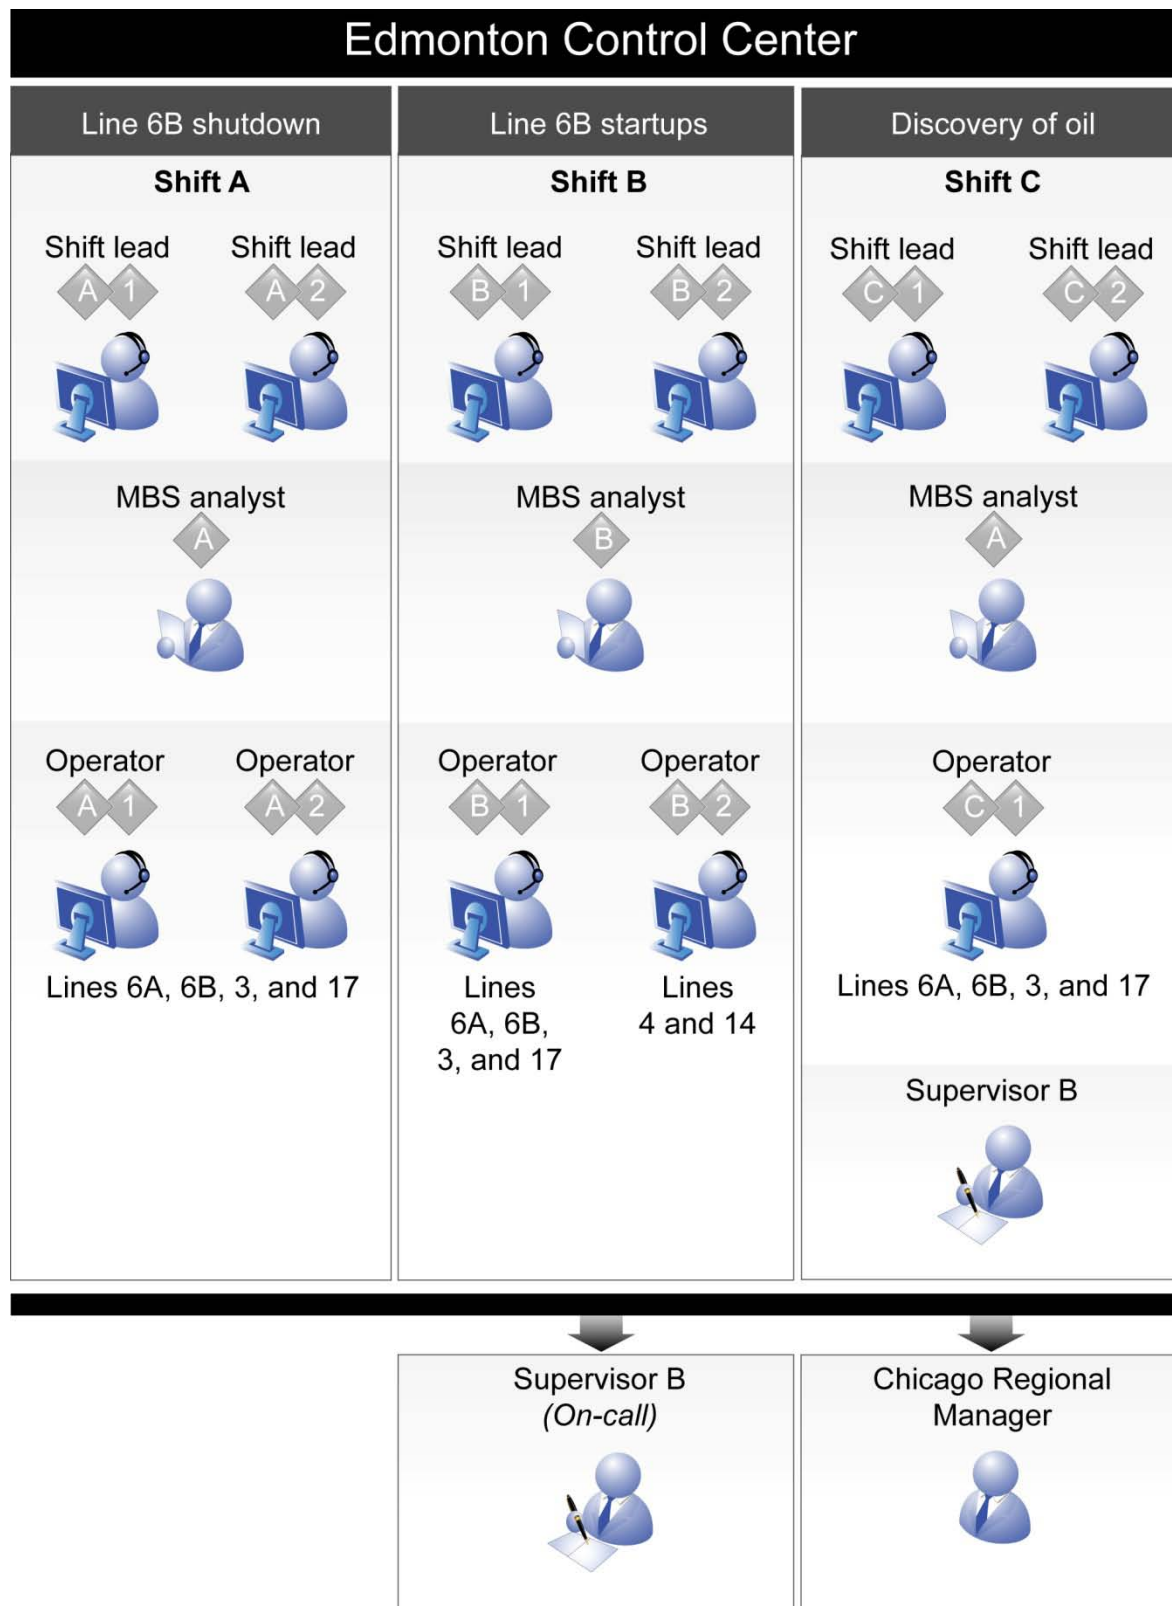
Figure 6. Key Enbridge staff involved in the 17-hour accident sequence. MBS refers to Material Balance System.

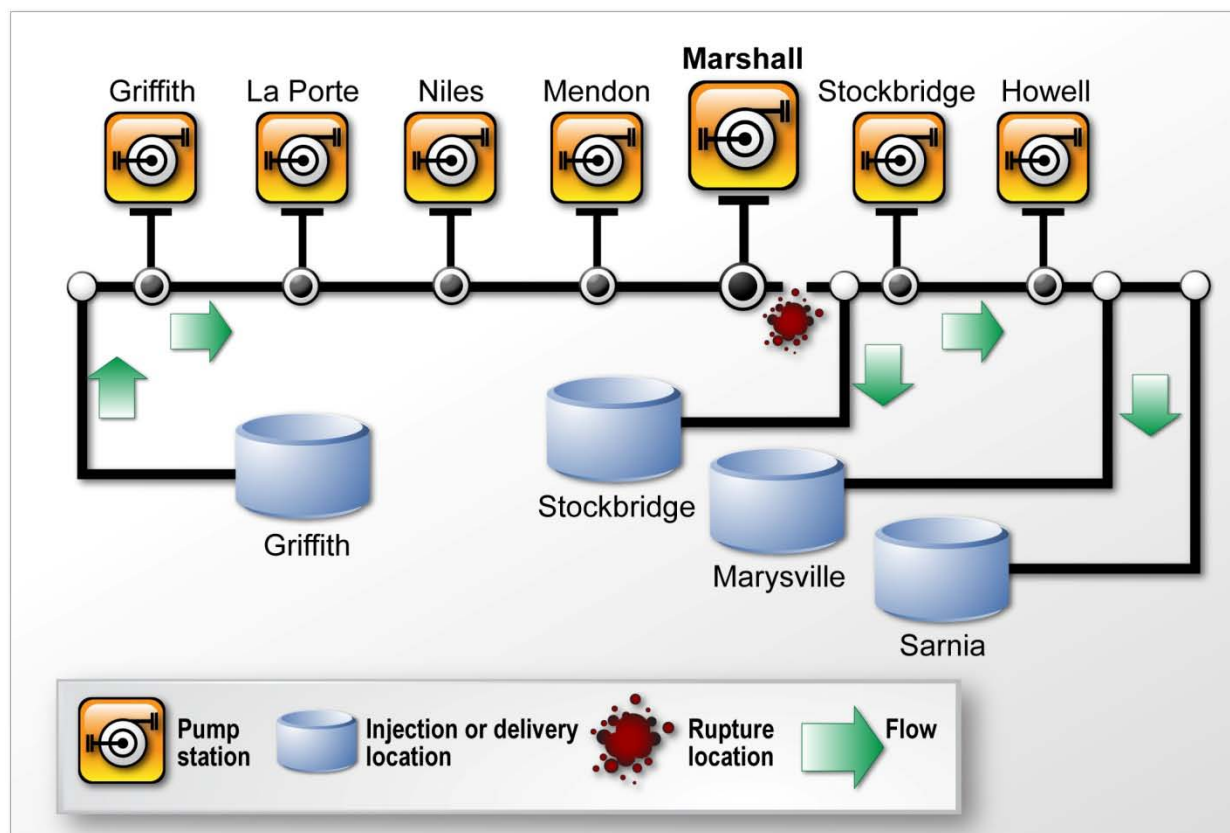
Figure 7. Simplified schematic of Line 6B, showing pump stations and delivery locations.

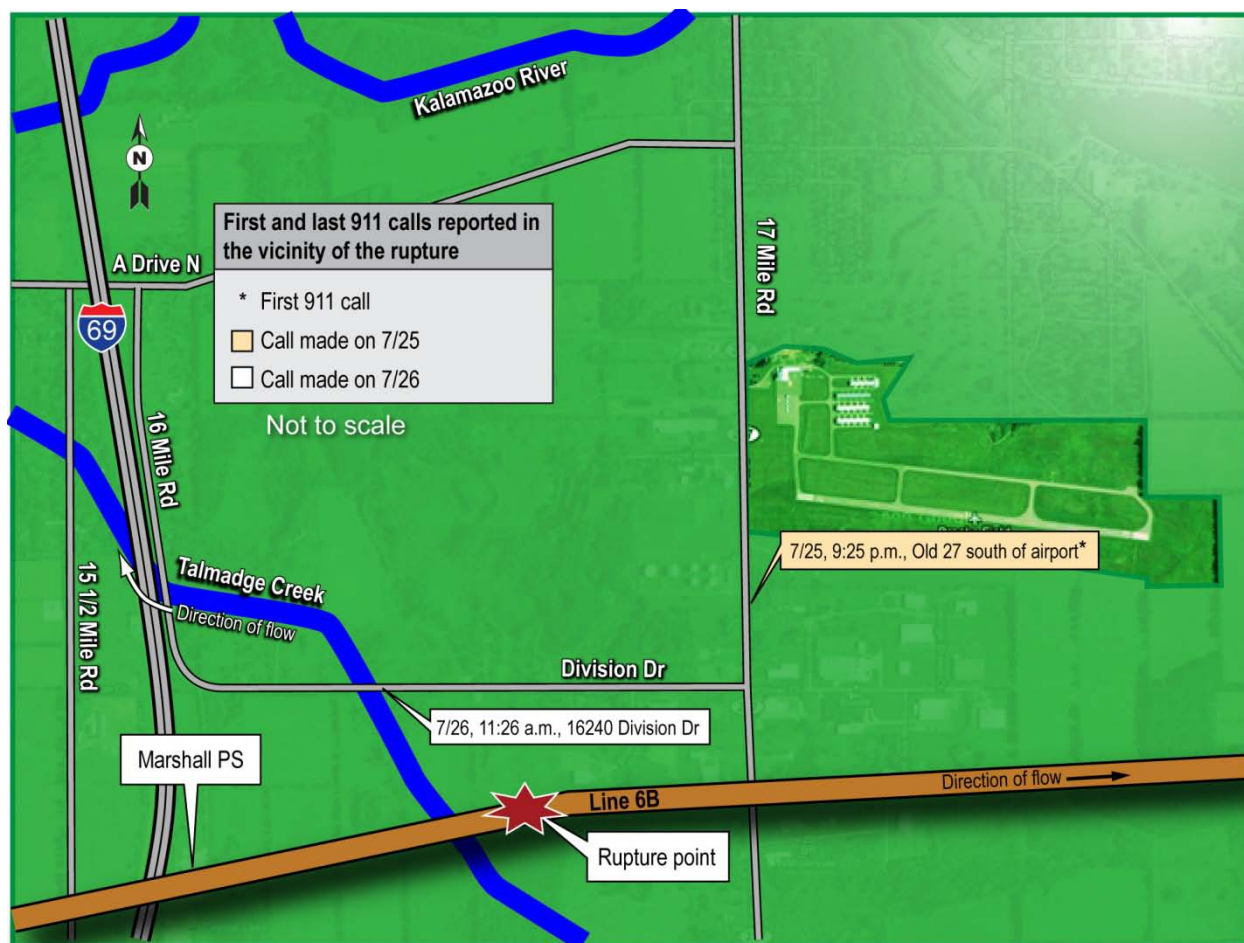
Figure 8. Emergency response and 911 calls from nearby residents. First and last calls are noted.

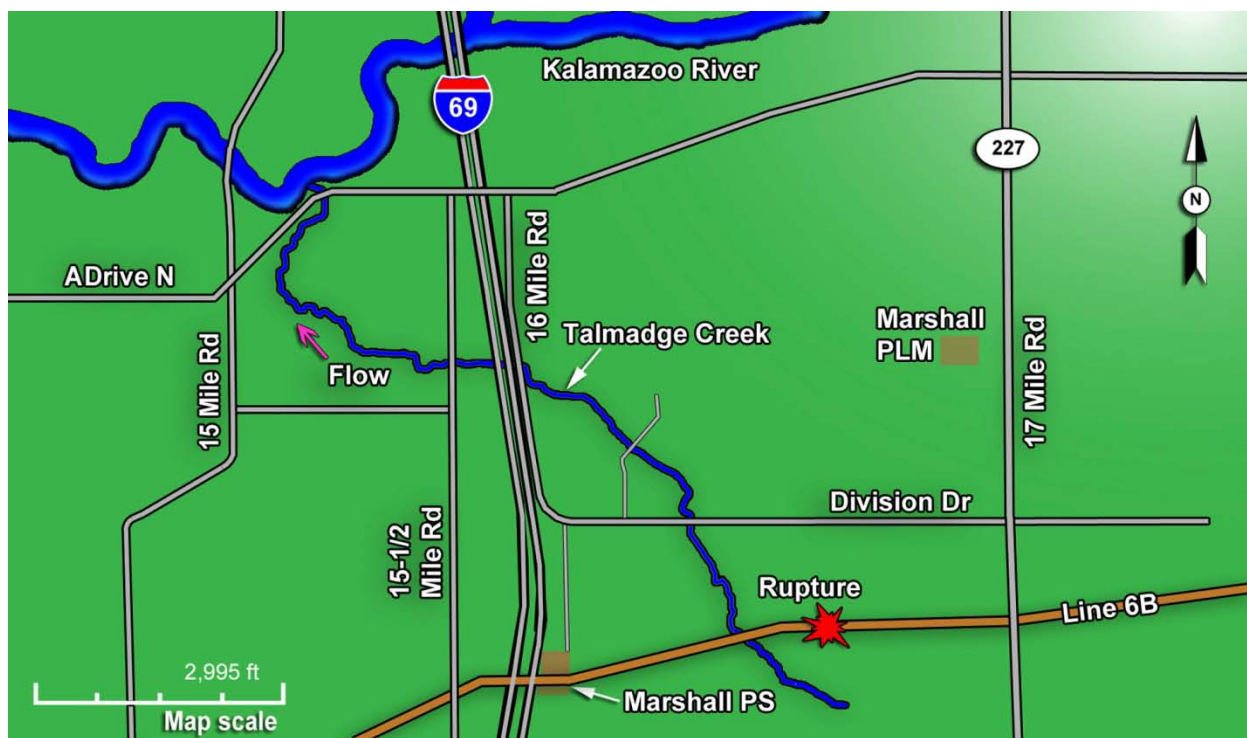
Figure 9. Area between rupture site and the Kalamazoo River where first responders concentrated efforts to contain the released oil.

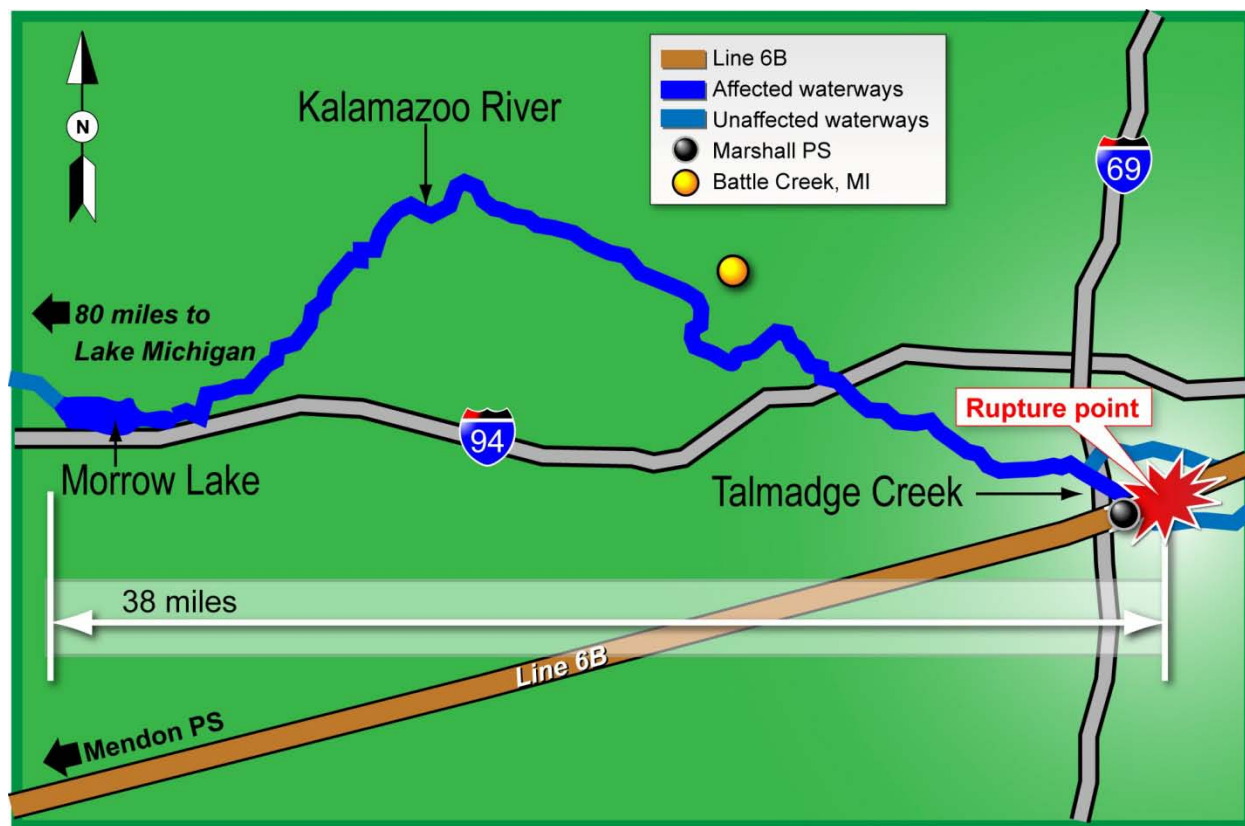
Figure 19. Map showing rupture location and affected waterways from Talmadge Creek to Morrow Lake.

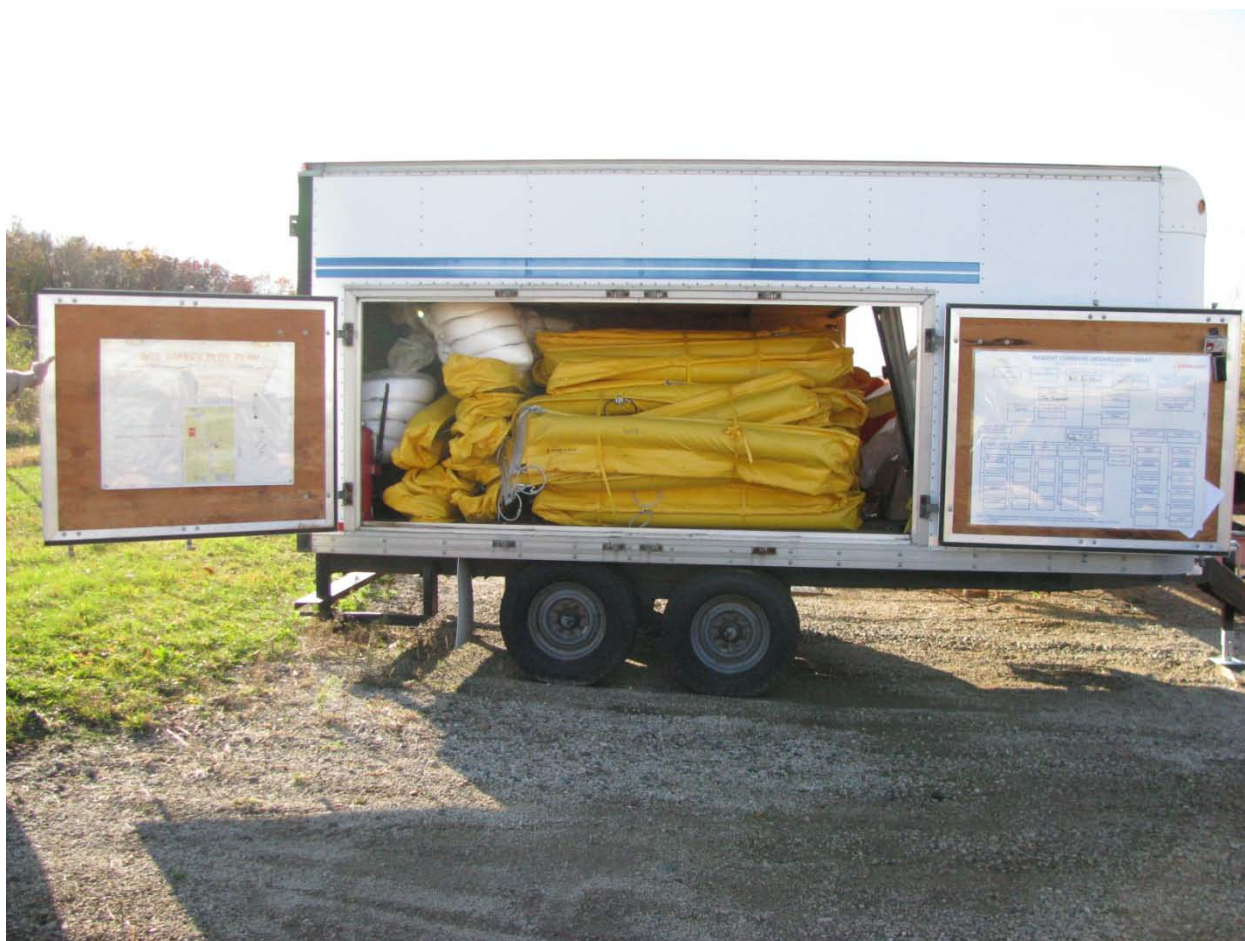
Figure 20. Enbridge PLM emergency response trailer containing the company's Tier 1 oil containment equipment, October 17, 2010.
