# Is Automated Driving Part of a Safe System Approach?

Member Michael Graham

April 3, 2023

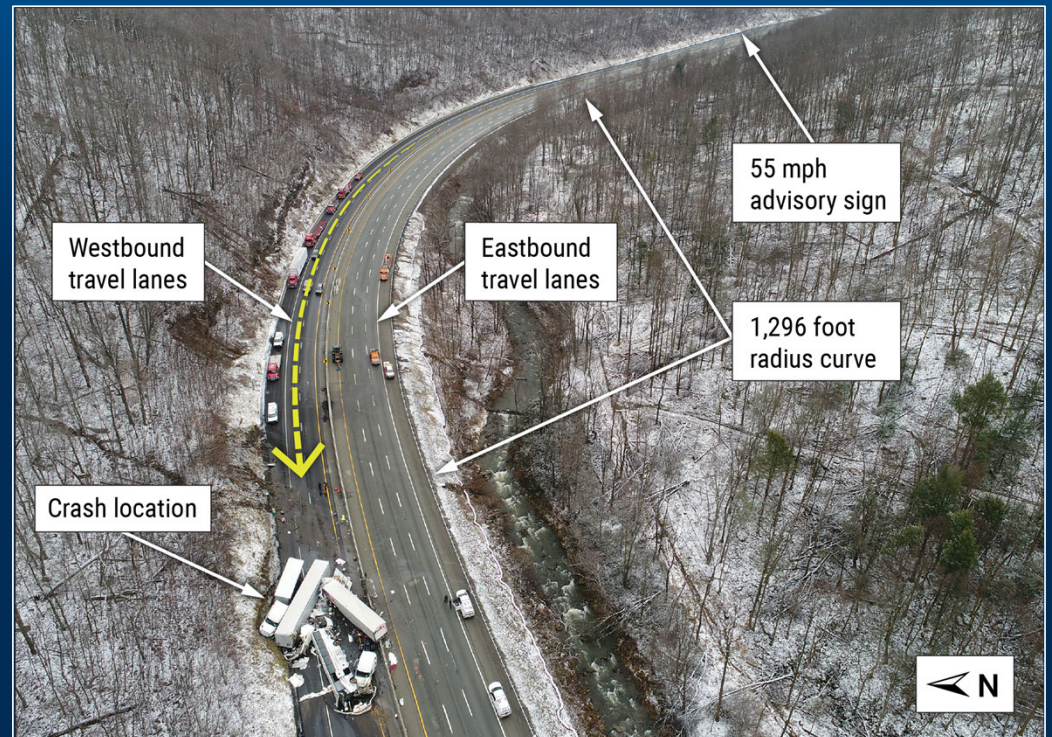
# Interstate 70/76 – Mt. Pleasant, PA

- January 5, 2020; 3:30am
- Slight precipitation
- Mountainous interstate curve with 55mph advisory speed
- Motorcoach entered curve at 77mph
- Excessive steering input from motorcoach
- Motorcoach overturned
- Initial position of rest blocked both lanes and shoulders

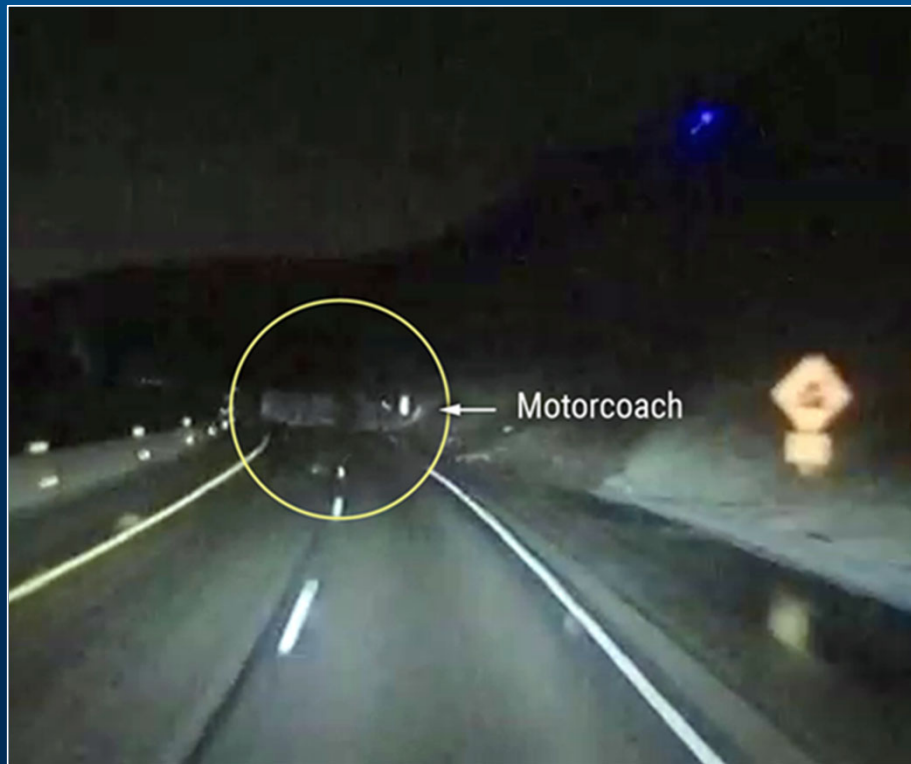
# Collision Avoidance Systems

Source: FedEx forward-facing video, annotated by NTSB

- FedEx-1, UPS-1, and UPS-2 all equipped with Collision Avoidance System –including AEB
- FedEx driver described overturned motorcoach as a “black wall”
- NTSB Finding: Circumstances of the impact for each of the three trucks were likely outside the capabilities of the collision avoidance system on the vehicles

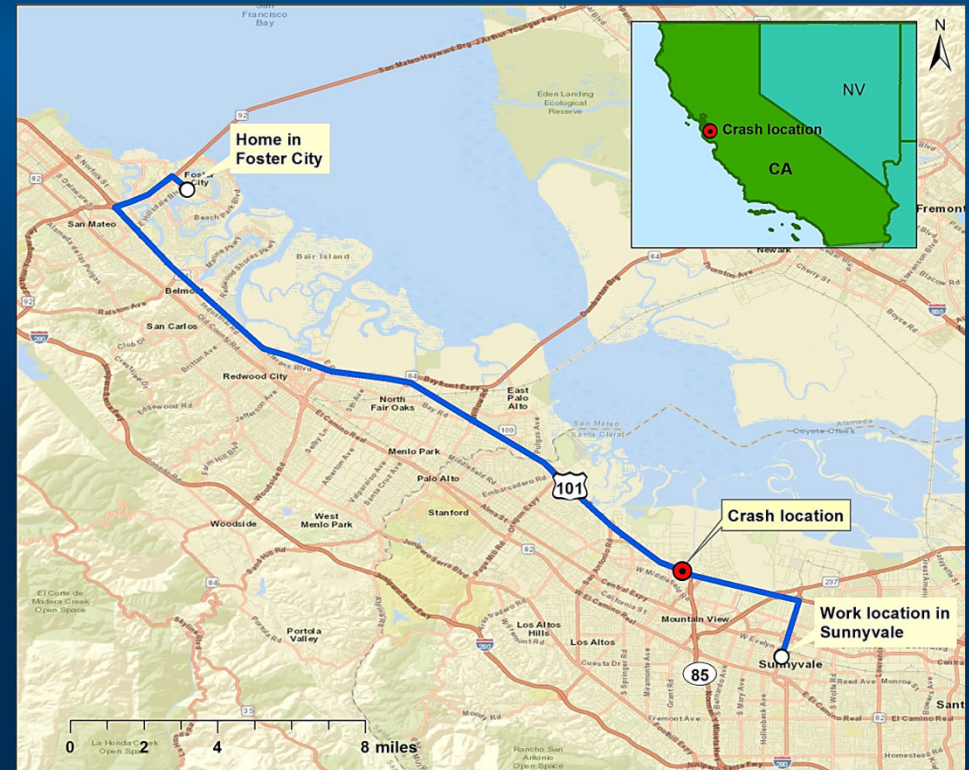
# Crash Overview

- Friday, March 23, 2018
- 9:27 a.m.
- Mountain View, California
- US-101 / SR-85 interchange
- 2017 Tesla Model X SUV
- 38-year-old driver
- Partial automation “Autopilot” engaged

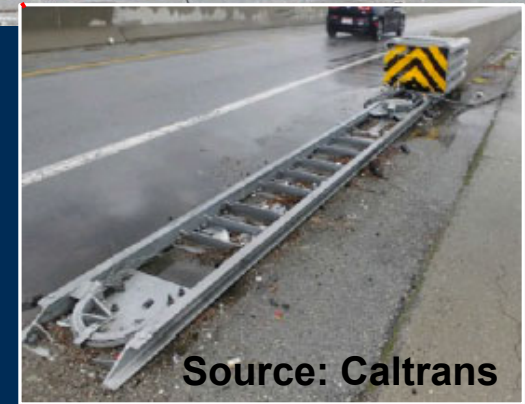
Crash attenuator was collapsed and nonoperational prior to the crash

Source: Caltrans

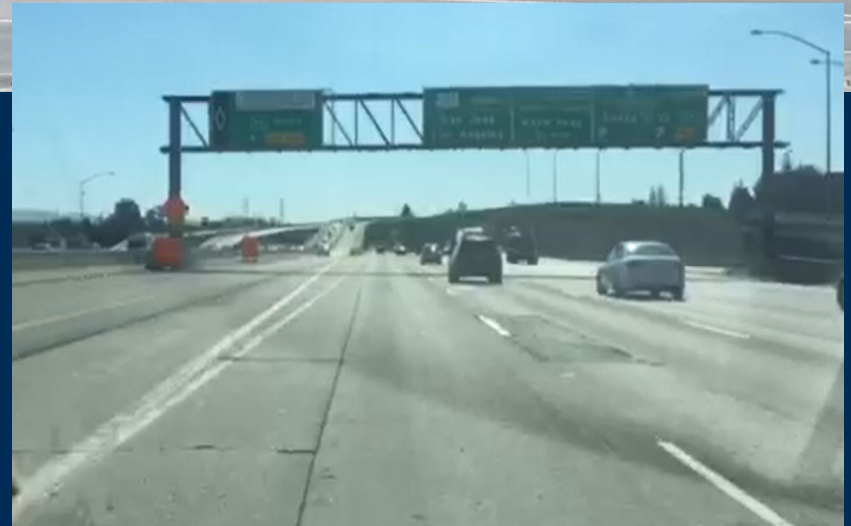
# Crash Sequence

Time to crash: 7.9 seconds  
Speed: 64.3 mph  
Lead vehicle: 83.7 feet  
Distance to crash: 748 feet

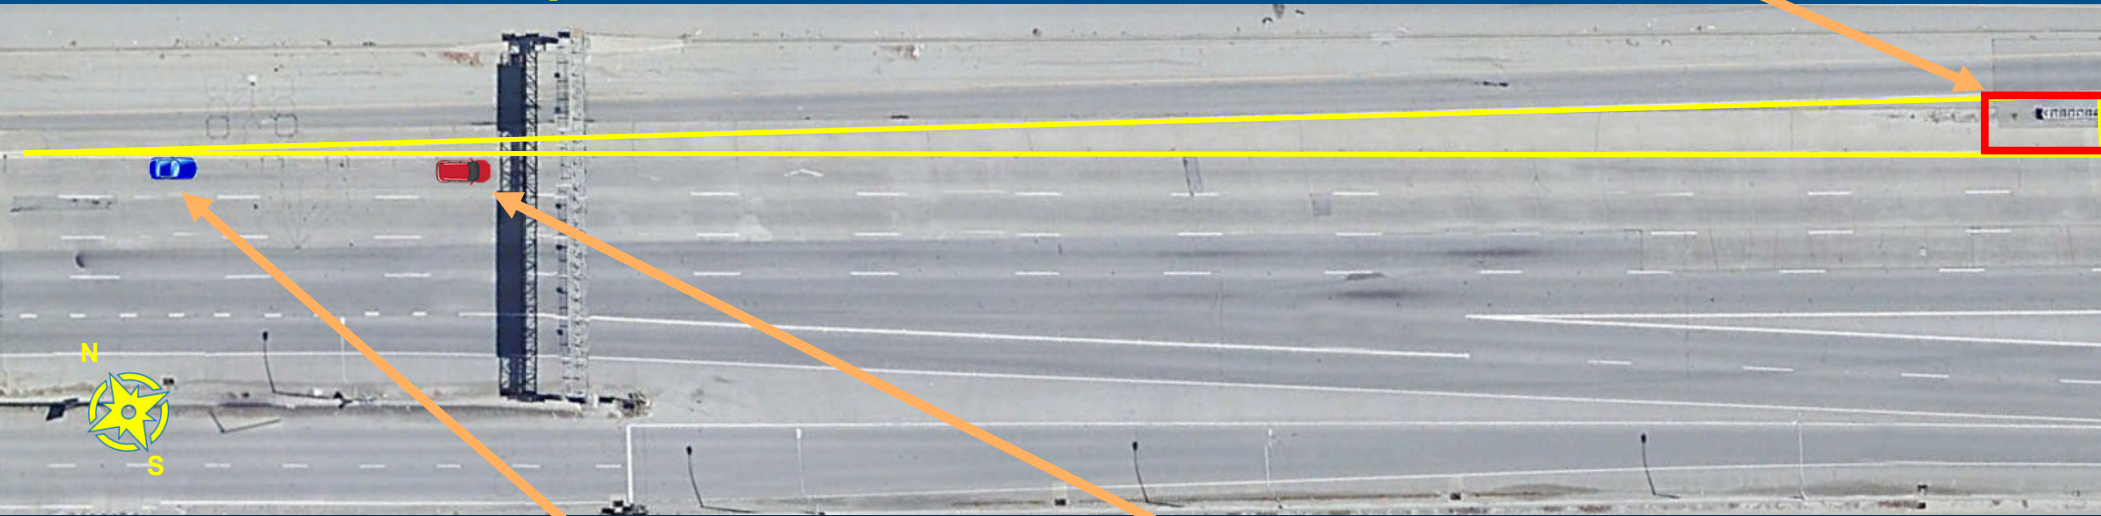
# Crash Sequence

| Time to crash: | 5.9 seconds |
| Steering: | 5.6 degrees left |
| Speed: | 64.1 mph |
| Lead vehicle: | 82 feet |
| Distance to crash: | 560 feet |
| Indication: | Hands-off steering wheel |

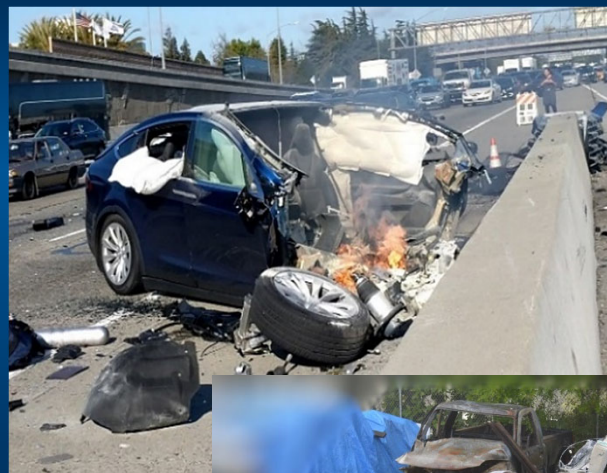
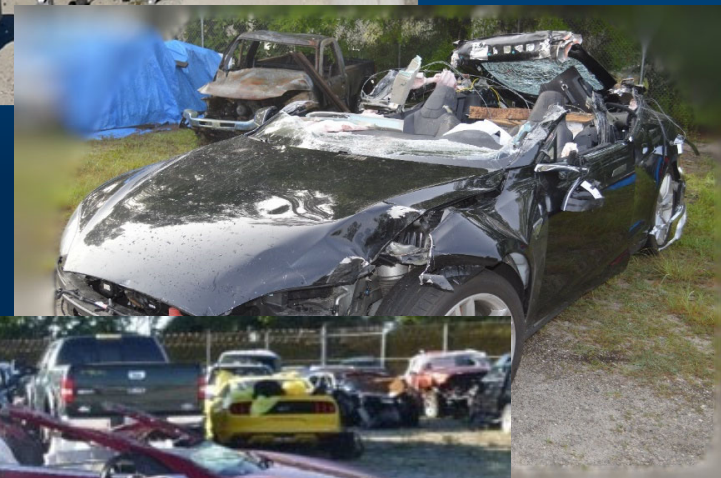
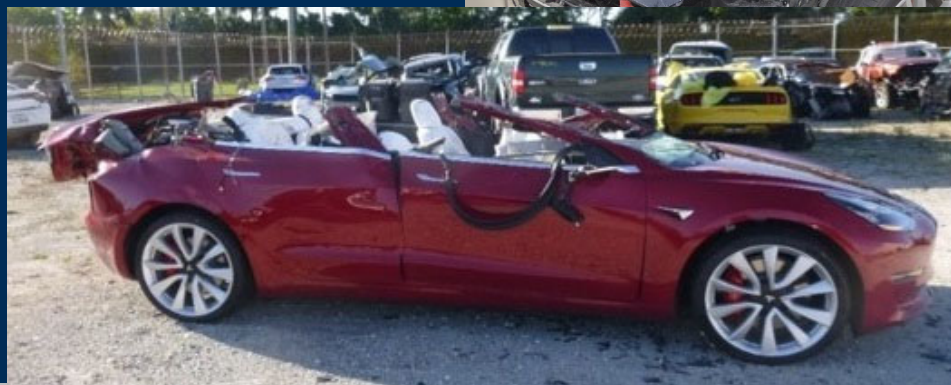
# Overreliance on Automation

- Circumstances in Mountainview similar to those of other Level 2 crashes: Williston and Delray Beach, FL; Culver City, CA
  - Driver-applied steering wheel torque not detected at time of impact –suggesting driver not engaged
  - Prolonged inattentiveness by drivers
  - Drivers were ineffective monitors
- Humans are poor monitors of automation
- An engaged driver remains a critical component even with advanced driver assistance systems

**Probable Cause:** The National Transportation Safety Board determines that the probable cause of the Mountain View, California, crash was the Tesla Autopilot system steering the sport utility vehicle into a highway gore area due to system limitations, and the driver's lack of response due to distraction likely from a cell phone game application and overreliance on the Autopilot partial driving automation system. Contributing to the crash was the Tesla vehicle's ineffective monitoring of driver engagement, which facilitated the driver's complacency and inattentiveness...
